Inorganic Coating System Halts Corrosion Under Insulation in Oil, Gas Assets

Oil and gas major Chevron (San Ramon, California, USA) recently revised its engineering standards to include a novel water-borne spray coating system to protect against both atmospheric corrosion and corrosion under insulation (CUI) at many of its worldwide facilities.

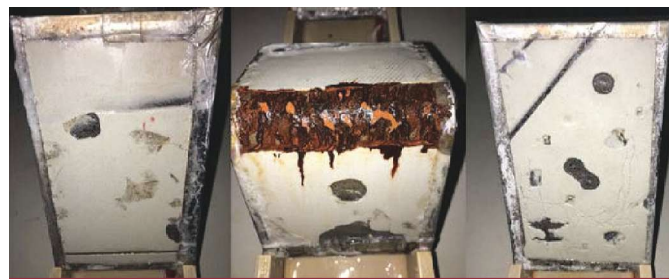
Panels with intentional damage after 335 h of ASTM B117 exposure. Photo courtesy of EUROCORR 2018.

the panel from a height of 3 to 4 m onto cement; using a saw blade to make a cut-like mark into the protective layer; and utilizing a mechanical polisher in some areas. In the most extreme case, one panel was bent at a 90-degree angle. The panels were evaluated after 335 h, and then after 1,870 h.

“In all cases, there is not rust in the areas where the panels were intentionally damaged,” the company writes. “An organic coating would have failed to control the corrosion in these conditions. Where new steel was exposed, that section of the panel rusted, as expected. But notice on the portion of the panel that was bent—at the edge of the coating, there is no rust along the entire line. Meaning, when [the coating] forms a chemical bond with the surface of the steel, the protective layer is formed. When this occurred, the mechanical integrity is maintained.”

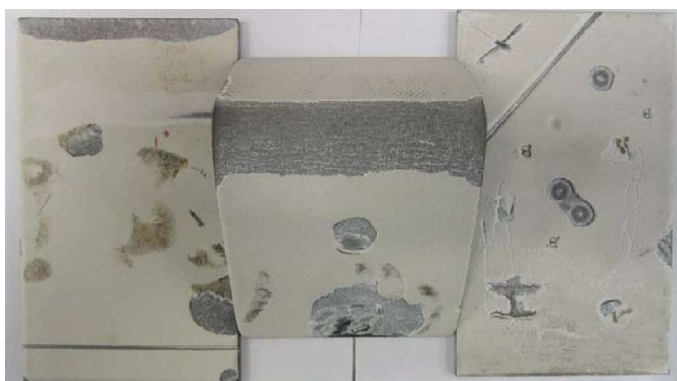
Sample panels with intentional mechanical damage. Photo courtesy of EUROCORR 2018.

To test the system’s mechanical integrity, panels were intentionally damaged. Damage was inflicted in ways such as dropping a ball on the panel; dropping

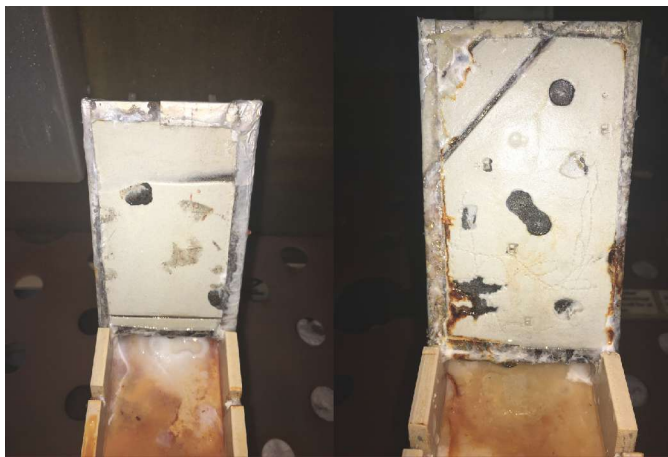
Panels with intentional damage after 1,870 h of ASTM B117 exposure. Photo courtesy of EUROCORR 2018.

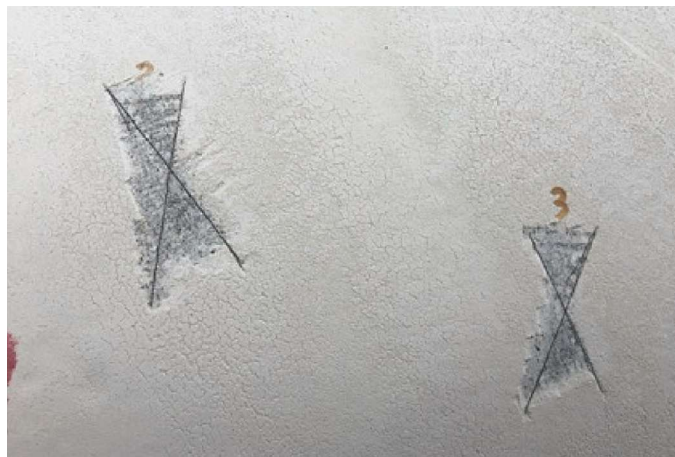
A cross-cut adhesion into the coating was examined four months after the pipe had been placed back into service. Photo courtesy of EUROCORR 2018.

Field testing under CUI conditions was done under a longer time period, including a pipe service insulated with blankets and running at temperatures ranging from 120 to 138 °C. Four months after performing a cross-cut adhesion into the coating, the system showed no rust.
