Seawater Corrosion Test Results

A Seawater corrosion test was conducted by spraying seawater 10 minutes out of every 4 hours. Actual seawater was brought from the Atlantic Ocean. We simulated sunlight by using sun lamps (426-nano-meter light waves) in continuous 4-hour intervals for 170 days.

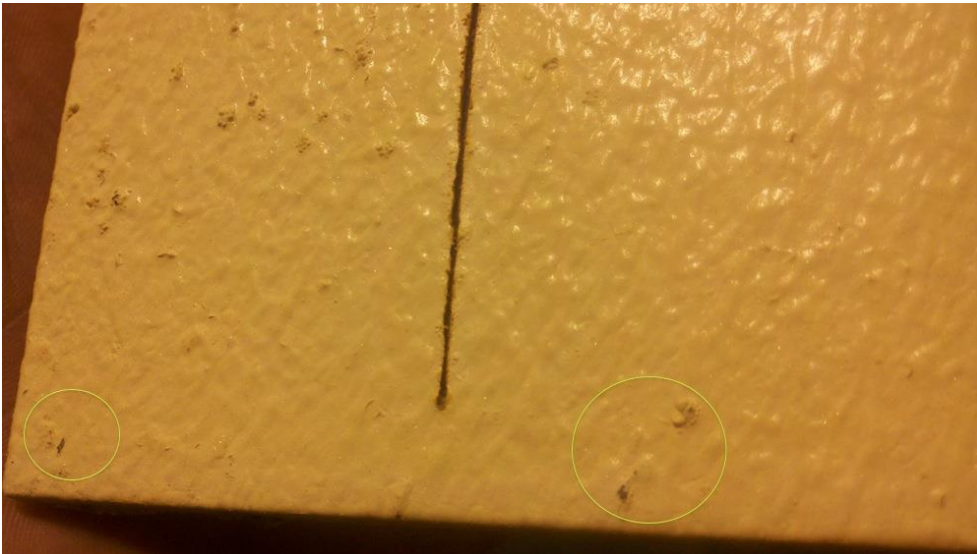
- Test Subject No.18: AFM Safe coat Primer + AFM Safecoat Top coat

Both coatings performed admirably and failed based on our testing standards between days 162 and 170.

No. 18 - AFM Safecoat Primer + AFM Safecoat Top Coat

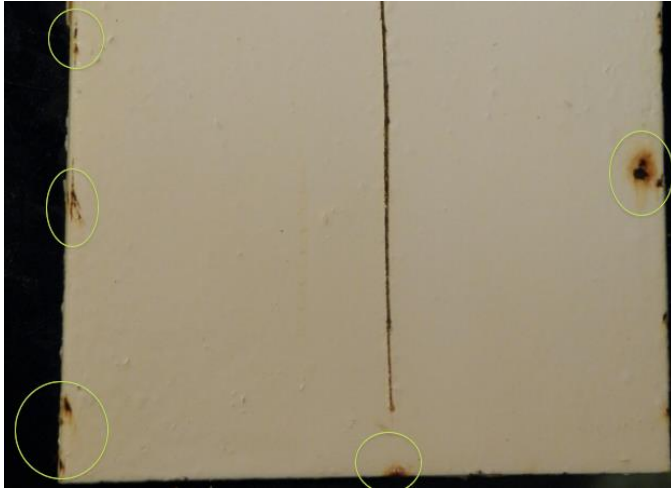
- Test Subject No.27: Rustoleum Pro High Performance Primer V-7580 + Top Coat Rustoleum V-7592

No. 27 - Rustoleum Pro High Performace Primer V-7580 + Top coat Rustoleum V-7592

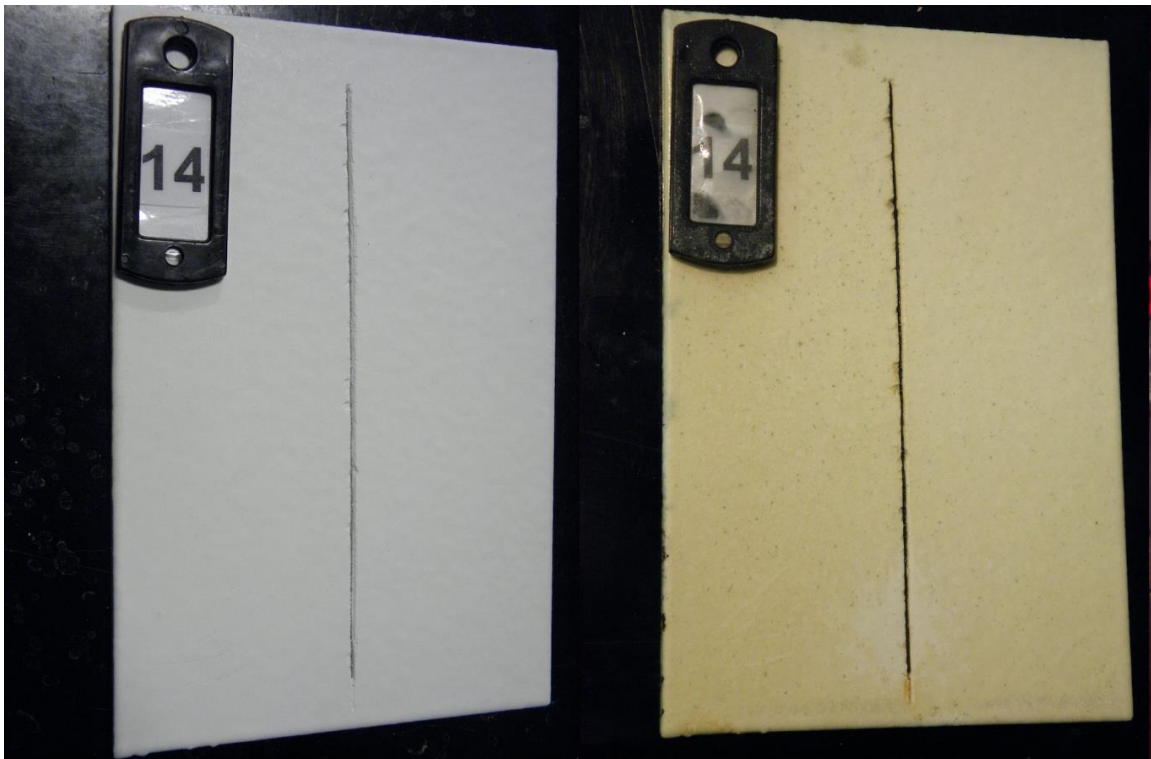
Inside The Chamber: Day 1 & Day 170
