EonCoat Corrosion Protection

Federal Railroad
Administration (FRA) Rail
Base Corrosion & Cracking
Prevention Study

Rail Base Corrosion and Cracking Prevention

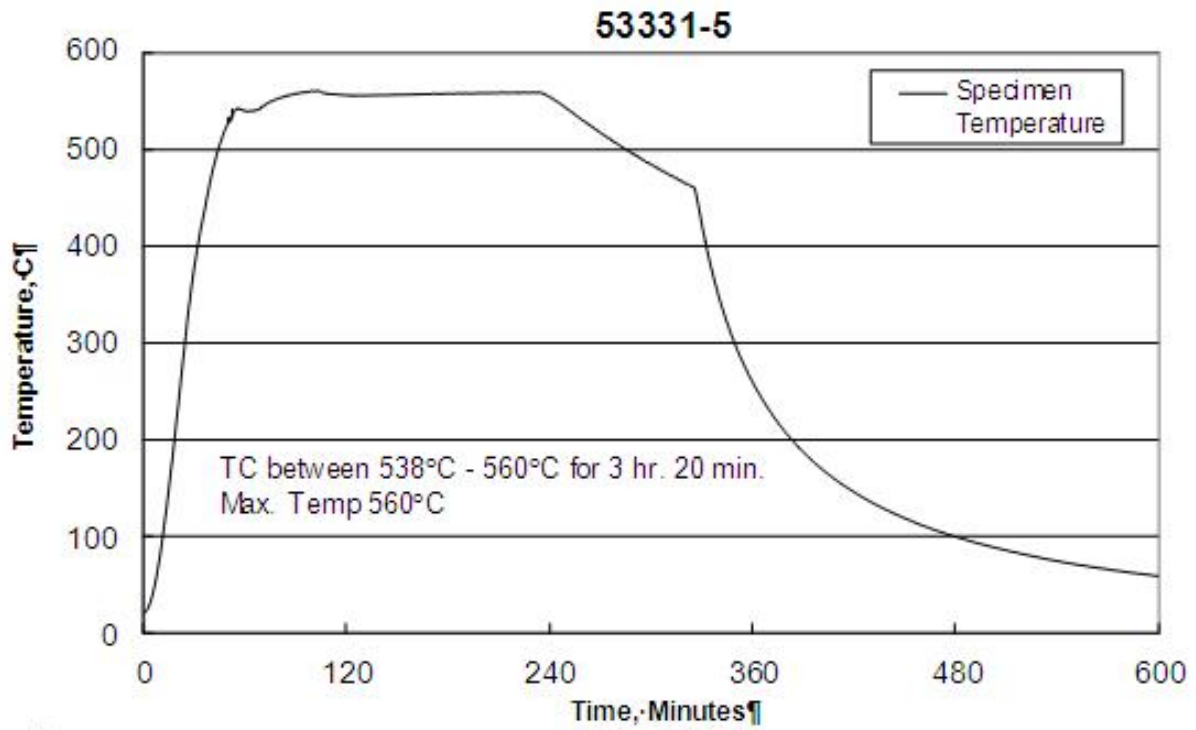
Figure 4. Bake Schedule for (ALL) Specimens

All the flange pieces and tie plates were grit-blasted to remove excess scale and rust. The appropriate treatments were then applied using the same approaches as those for Task 1. The ALL three-step samples were baked at 550°C for 3 hours to set the zirconium oxide sol-gel sealer. The samples, as placed into the bake furnace, are shown in Figure 3, and the thermocouple trace for the bake is shown in Figure 4.

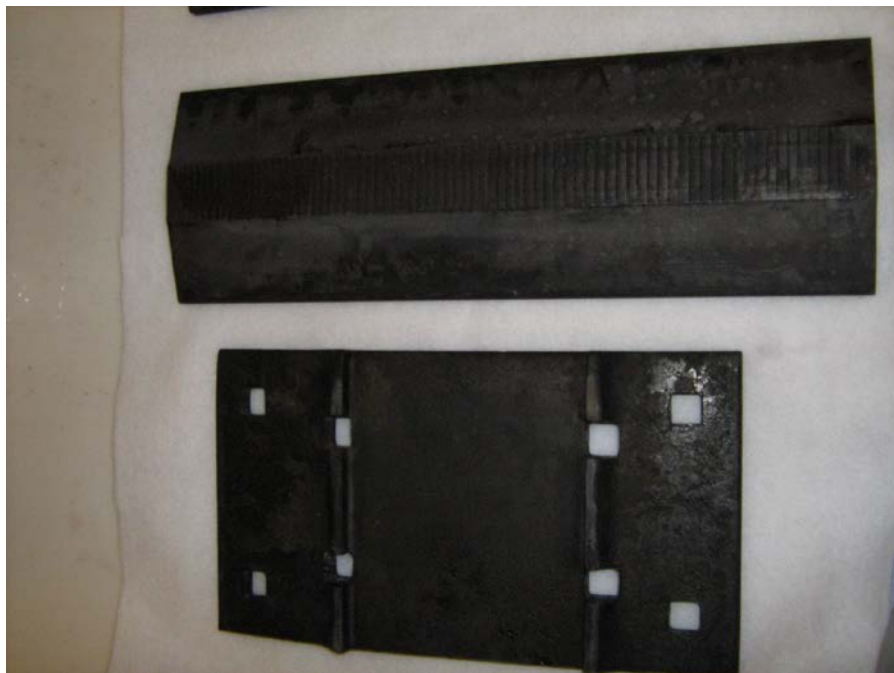
Figure 5. PD Two-Step Treated Sample Set

Figure 5 through Figure 8 show the specimens just prior to corrosion exposure.

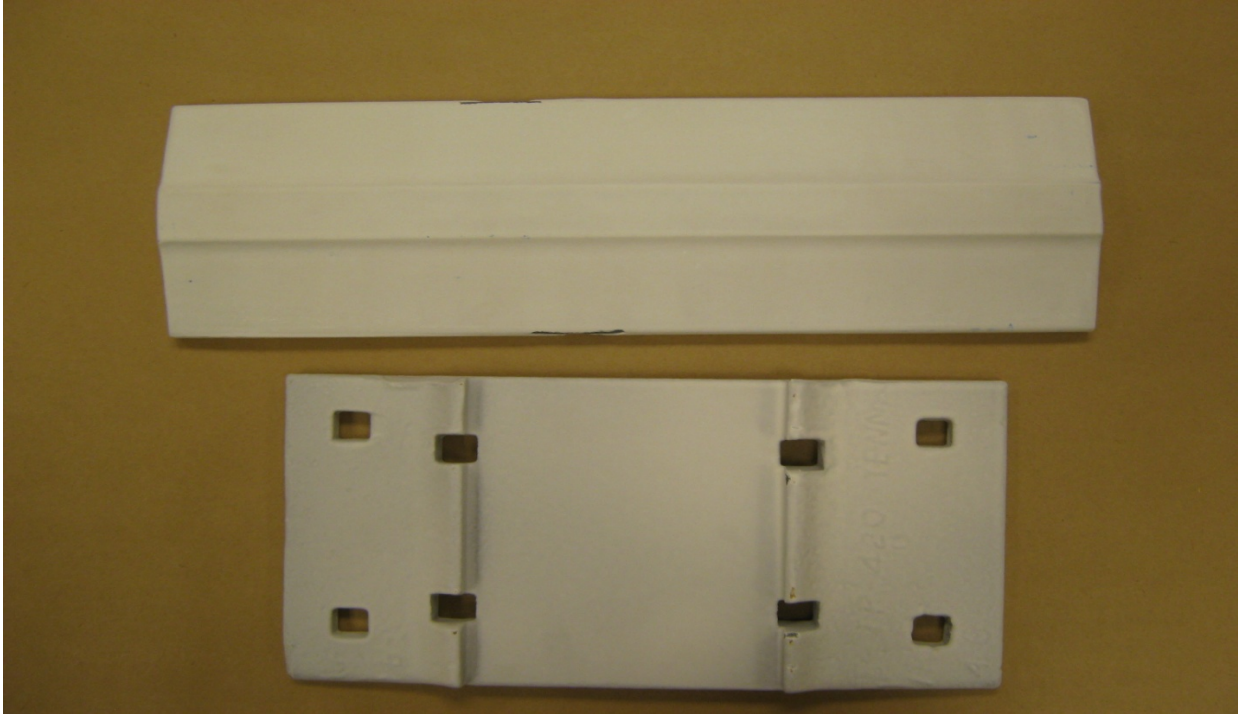
Figure 7. EonCoat® Treated Sample Set

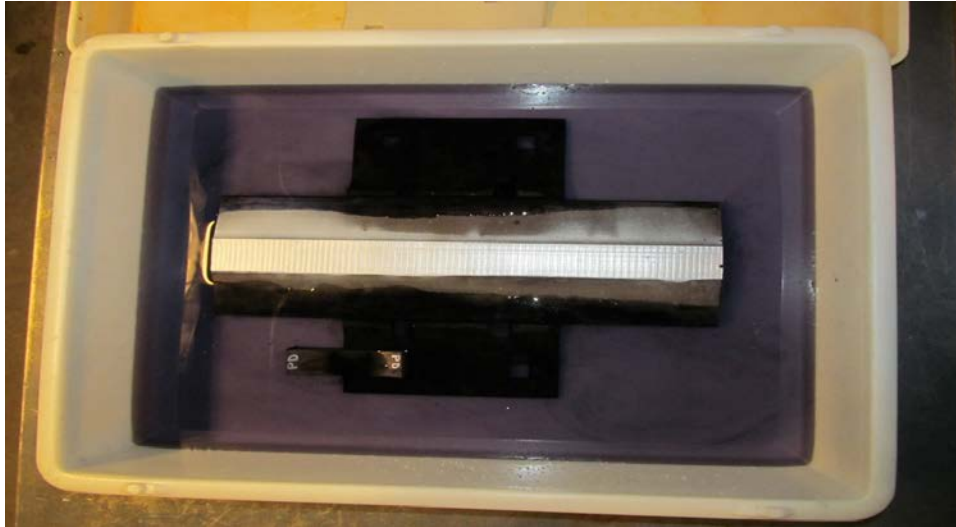
Figure 9. PD Samples on First Exposure to Saltwater

The saltwater solution was fixed at 5 percent by weight in a water solution of road deicing salt in tap water. Deicing salt contains magnesium chloride and calcium chloride in addition to the predominant sodium chloride. When the samples were first placed in saltwater, the PD system began to bleed blue-black color. (This also happened with the small-scale test bars in Task 1.) It was found later that this only happened when first immersed. In subsequent weeks of exposure, there was no additional bleeding (see Figure 9).

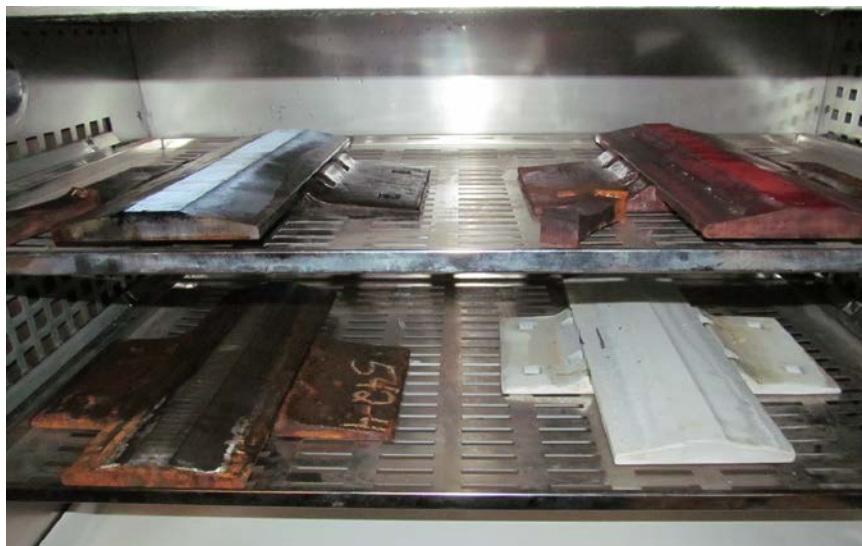
Figure 10. Placement of Samples in Humidity Cabinet

The hot-wet exposure took place in a large temperature and humidity controlled cabinet set at 50°C with saturated humidity. For the humidity exposures, the stacked specimens were placed into the controlled temperature-humidity cabinet, as shown in Figure 10. Notice it is possible for condensate from the upper samples to drip down onto the lower samples.

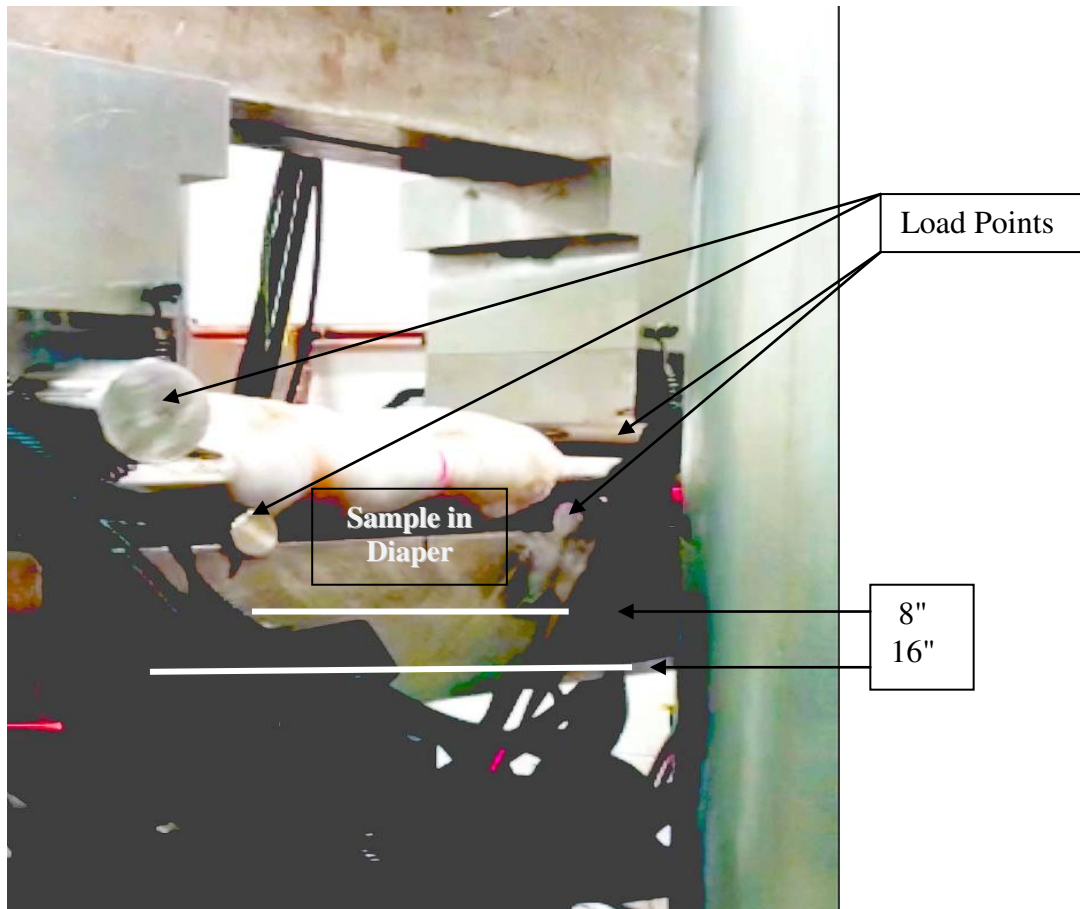
Figure 11. Four-Point Load Fatigue Test Setup

The purpose of this task was to test the combined effects of damage (notch), surface protection, and corrosion on the fatigue performance of lower flange sections of rail. Fatigue loading was applied with rollers in a four-point bending arrangement. The center rollers were spaced at 8 inches and contacted the top surface adjacent to the radius of the rail. The outside rollers contacted the lower surface of the flange at 16-inch spacing (see Figure 11). Testing was performed at about 7 Hz.

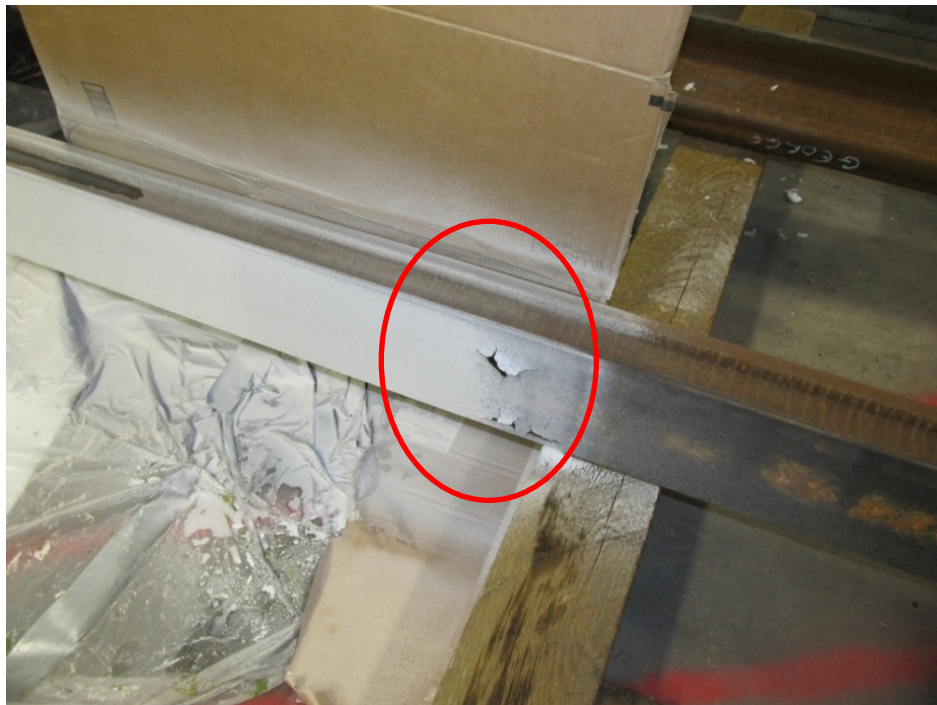
Figure 15. EonCoat® Sprayed Rail Segment

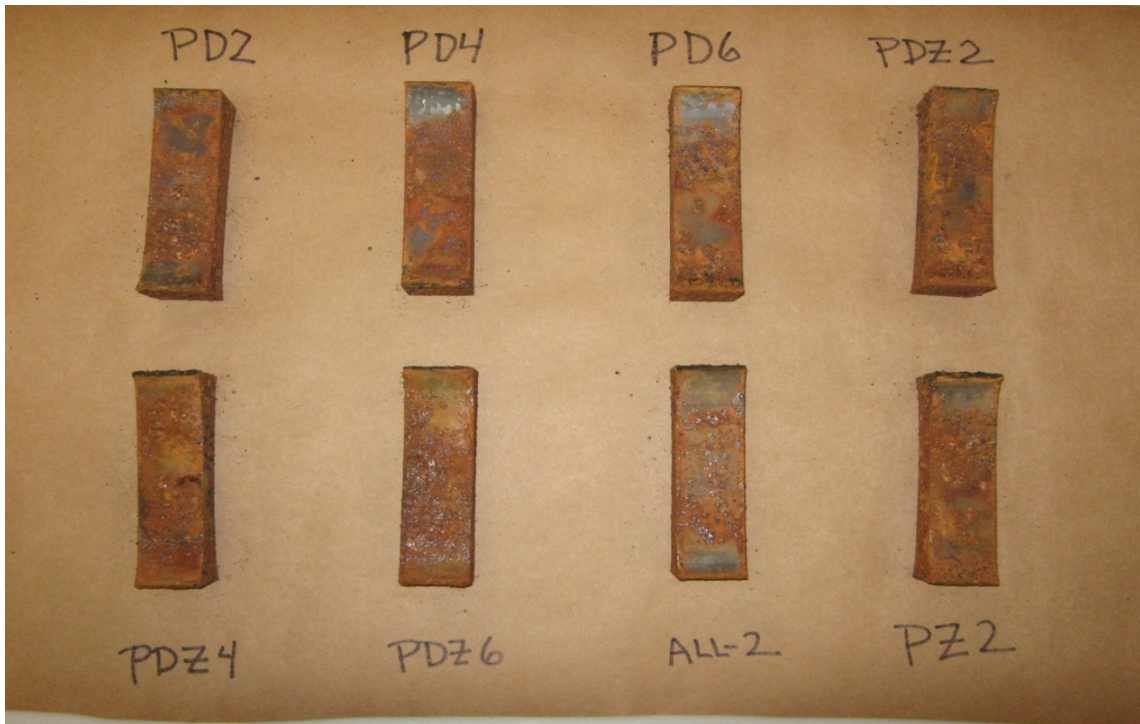
Figure 17. Bottoms of Samples after 3-Week Corrosion Cycle

One of the more striking observations was the degree of overall corrosion attack after 3 weeks compared with 2 weeks. The corrosion became quite aggressive during the third week. The results show that the ALL variant, which had the three-step application system with final bake, performed best in protecting the bottoms. However, the best performance for protecting the tops was the PD variant, which is a two-step process with no bake.

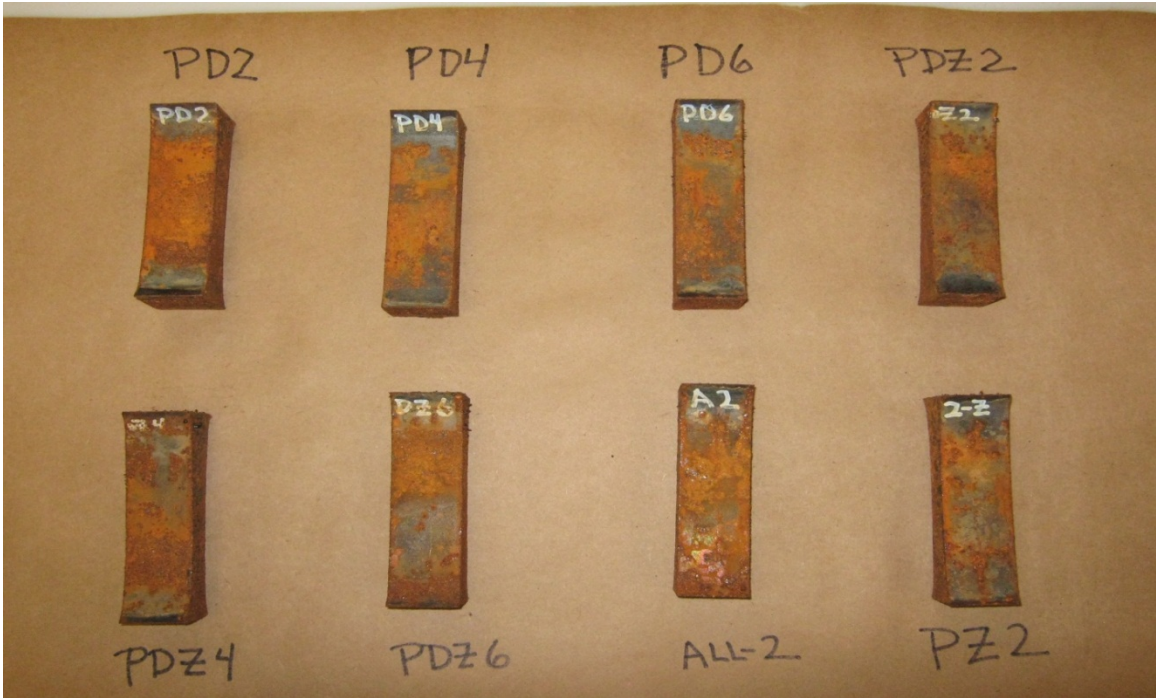
Figure 18. Tops of Samples after 2-Week Corrosion Cycles

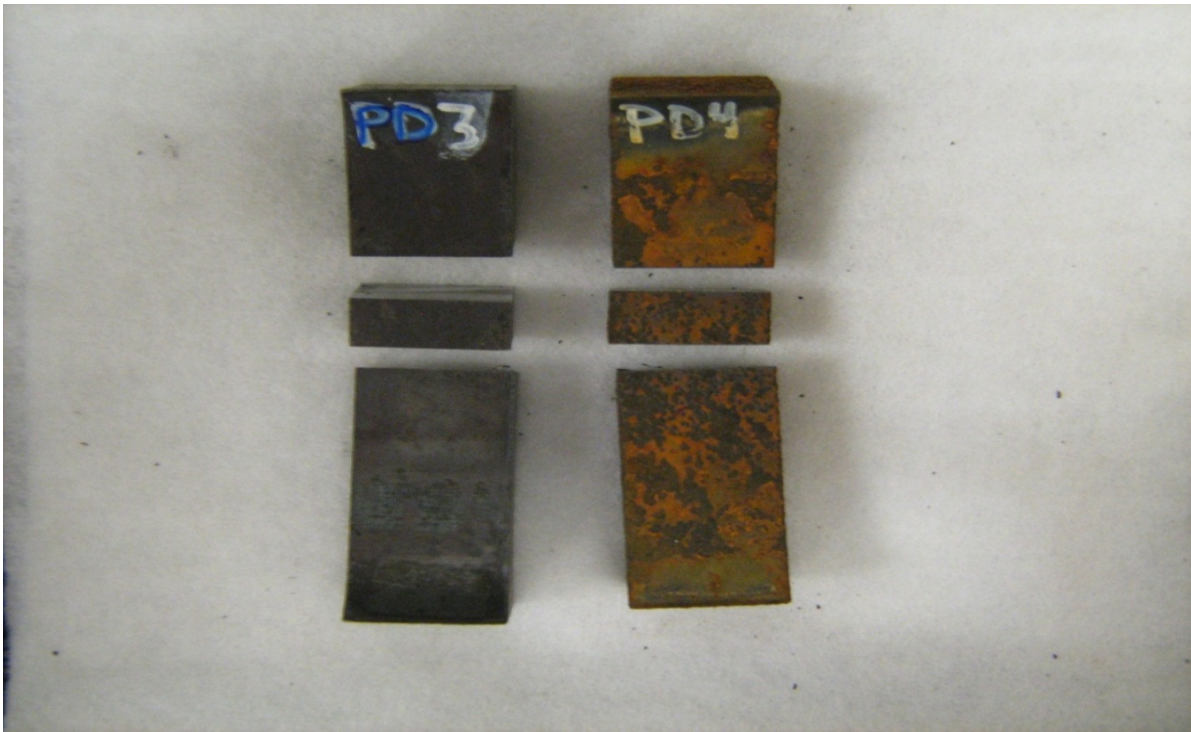
Figure 21. Close-Up of PD3/4 Series

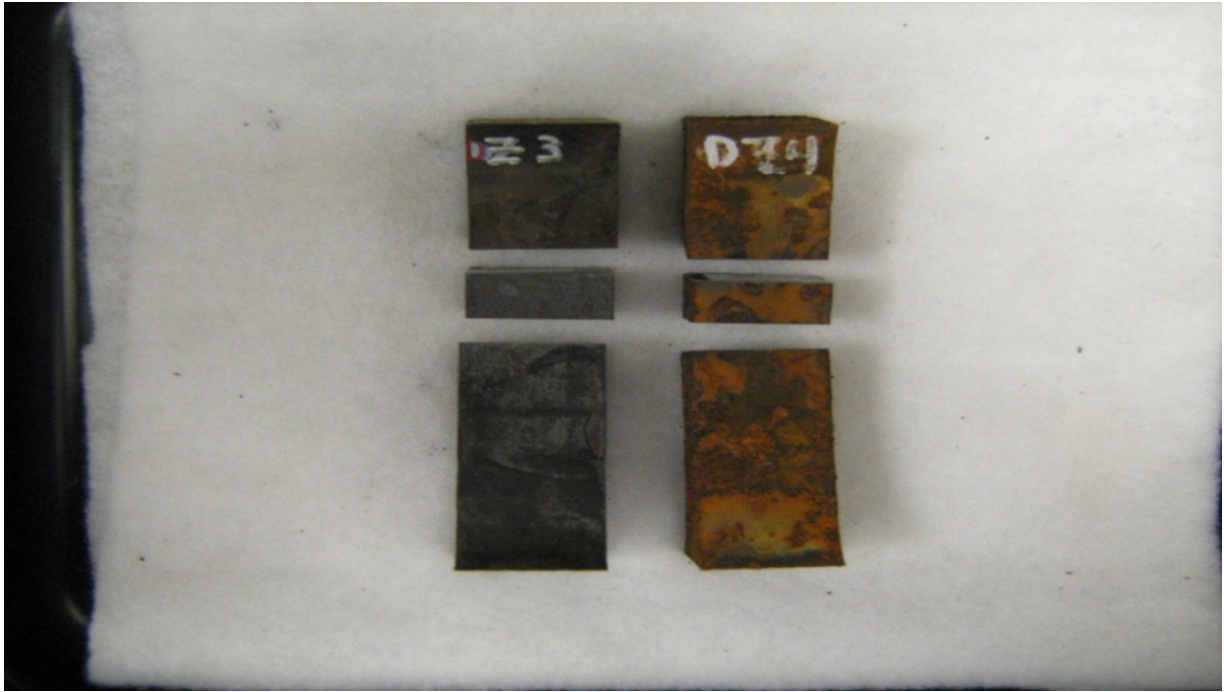
Figure 22. Close-Up of PDZ3/4 Series

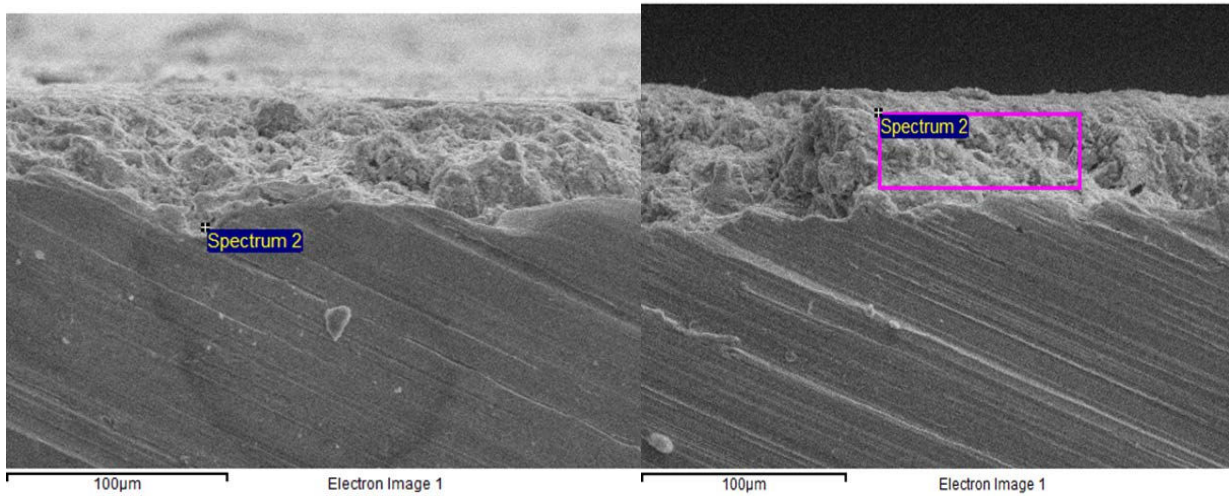
Figure 24. SEM Photographs of Cross Cuts for PD3 (Left) and PD4 (Right)

For the following discussion, recall that odd-numbered sample types were treated, but not exposed to corrosion. Even-numbered sample types were treated and exposed to corrosion. Representative SEM photographs are shown for PD3 and PD4 (Figure 24), PDZ3 and PDZ4 (Figure 25), and ALL1 and ALL2 (Figure 26). These were taken at 1000× to accentuate the interfacial zones and the coatings themselves. The areas marked “Spectrum” show the scan locations for the EDS analysis.

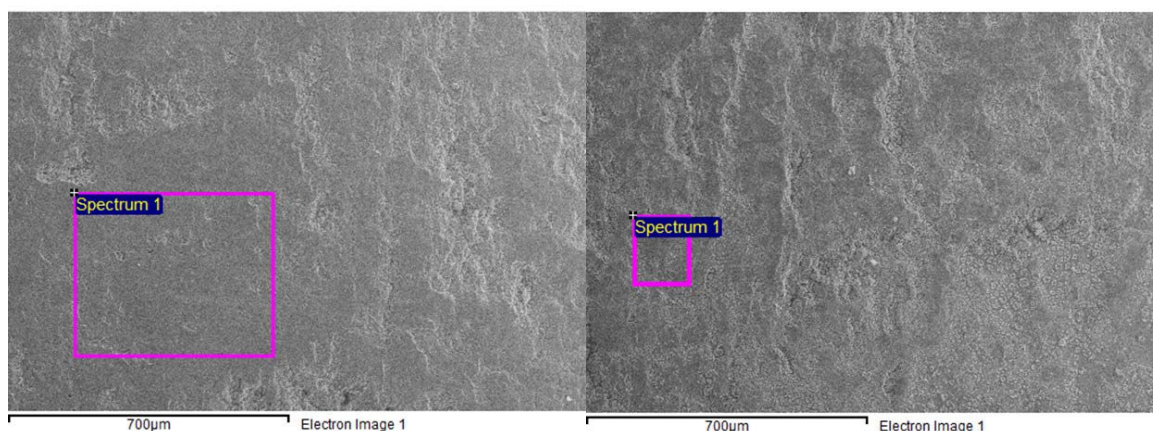
Figure 27. SEM Photographs of Top Surfaces for PD3 (Left) and PD4 (Right)

In general, the physical topologies were unremarkable. Cracking found in PDZ3 might be from the zirconia sol-gel. Sol-gels are susceptible to mud-cracking if dried or condensed too rapidly. Localized thickness variations leading to drying stress can also cause sol-gels to mud-crack as they dry and react. One might expect the same topology for PDZ4 as for PDZ3, since it was not baked, but that was not evident in the sample examined. As shown in Table 8, the amount of surface zirconium dropped in PDZ4 after the corrosive exposure. The mud-cracked zones could be expected to be more sensitive to “etching” so they may have been attacked preferentially during corrosion.

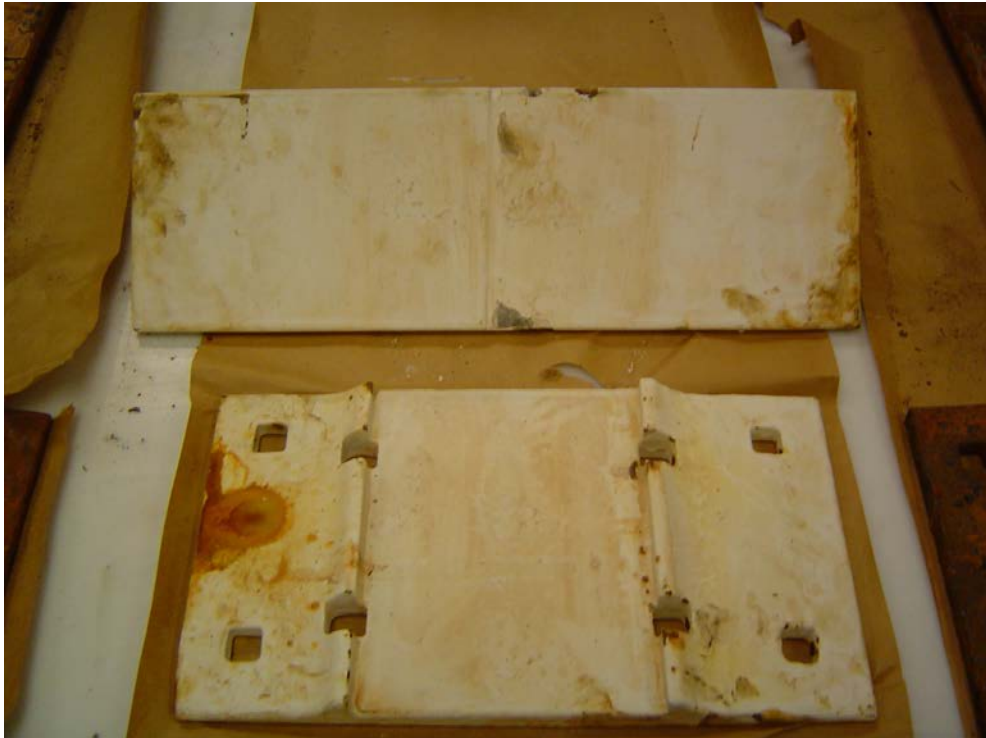
Figure 33. EonCoat® Samples after 3-Week Exposure

Based on visual examination, the EonCoat®-treated sample showed considerable resistance to the combined corrosion cycles. The rust spots on the EonCoat® surface were caused by condensate from the specimen on the shelf above it in the humidity cabinet. A beneficial observation was that areas of the EonCoat® that had been chipped or physically damaged in handling still did *not* succumb to corrosion attack.

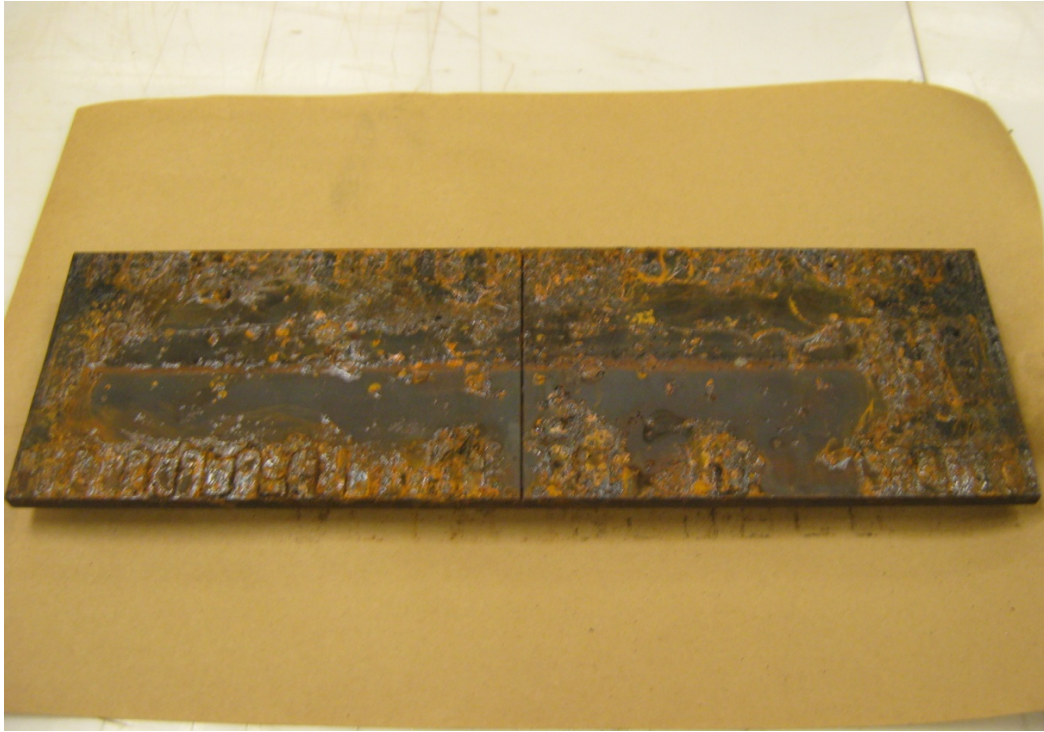
Figure 35. Drip Zone Bottom Surface after 3 Weeks

The results after 3 weeks for the top and bottom of the drip zone sample are shown in Figure 34 and Figure 35, respectively. In both cases, the protected portions were on the bottom half of the photographs. The protection on the bottom half of the top surface was fairly good. The protection for the trapped portion on the flange bottom was fair, but noticeable. There was possibly some benefit from the ALL treatment, and it might prolong rail life in actual service, but the protection was not dramatic.

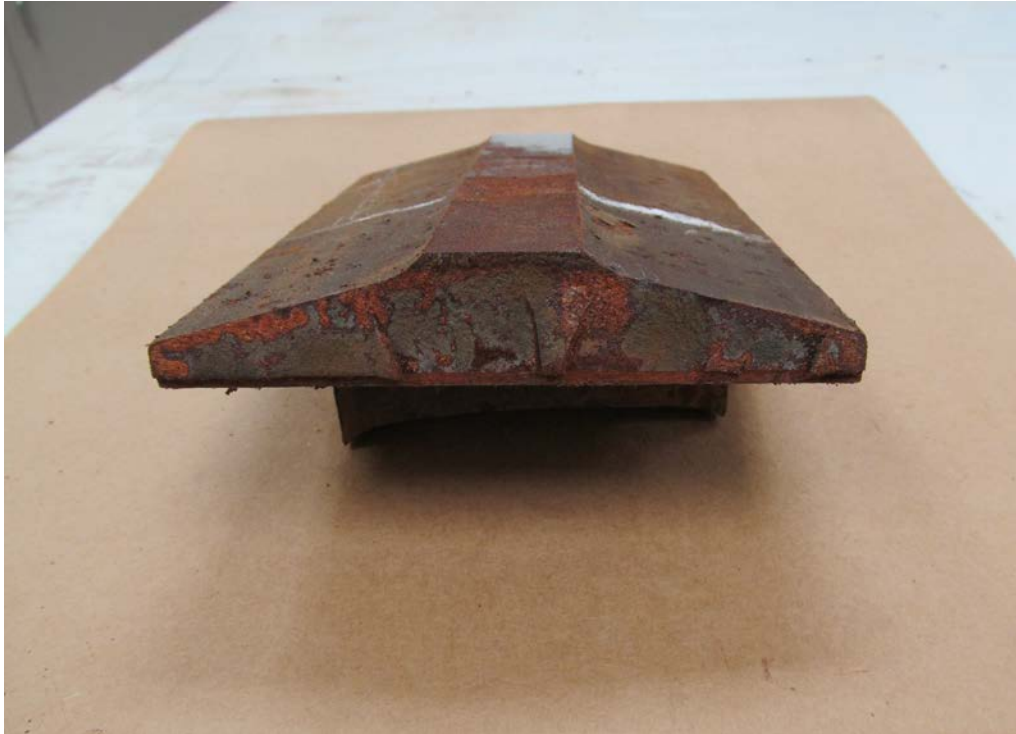
Figure 36. Fracture Surface of Corroded Sample with No Protection

The fracture surfaces for Sample #2 (NONE) and Sample #4 (ALL) are shown in Figure 36 and Figure 37, respectively. Notice the advance of corrosion in the damage zone is greater for the sample with no protection than for the sample with corrosion protection.

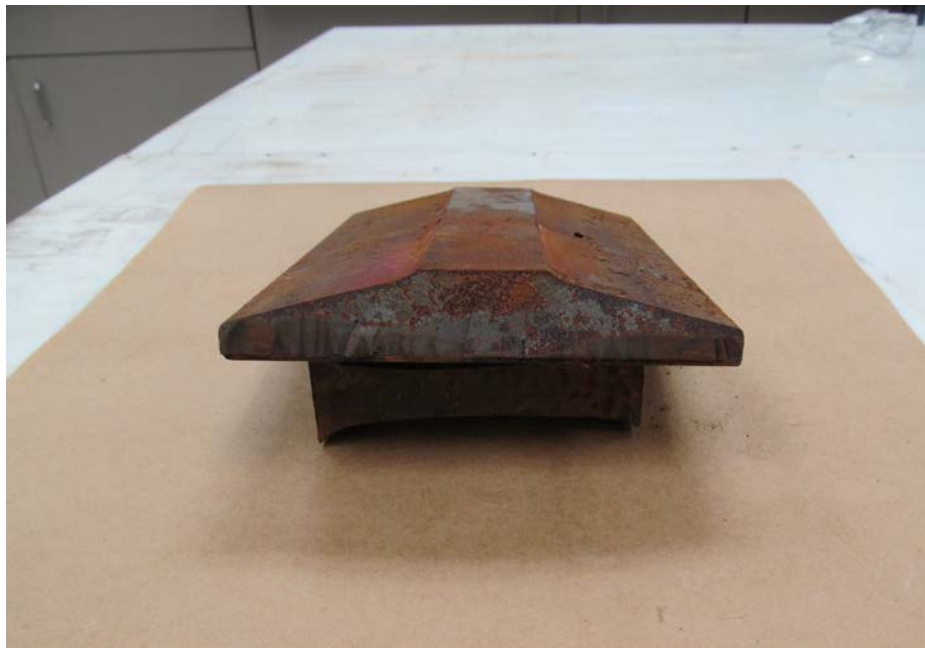
Figure 37. Fracture Surface of Corroded Sample with ALL Treatment

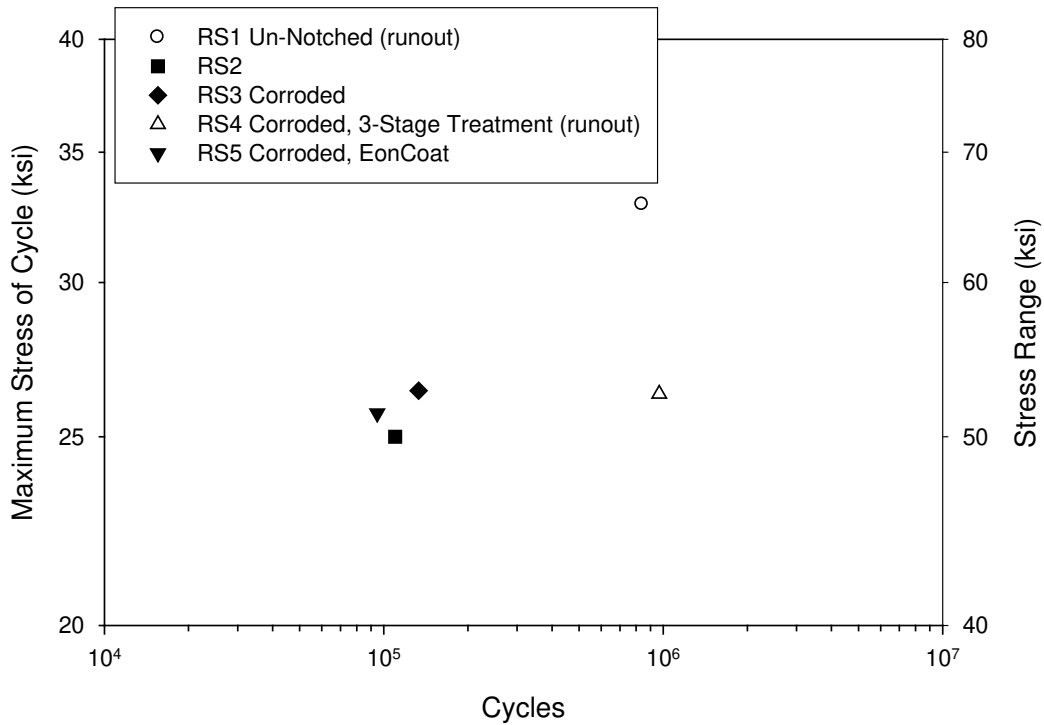
Figure 38. Resonant Fatigue Test Lifetime Results

One of the more significant findings of this test was that asymmetrical cross sections, such as rail, could be induced to self-resonate by this method. Previously, only circular cross sections (i.e., pipe and girth welds) had been tested with resonant fatigue, and the ability to put rail segments into oscillation was noteworthy.

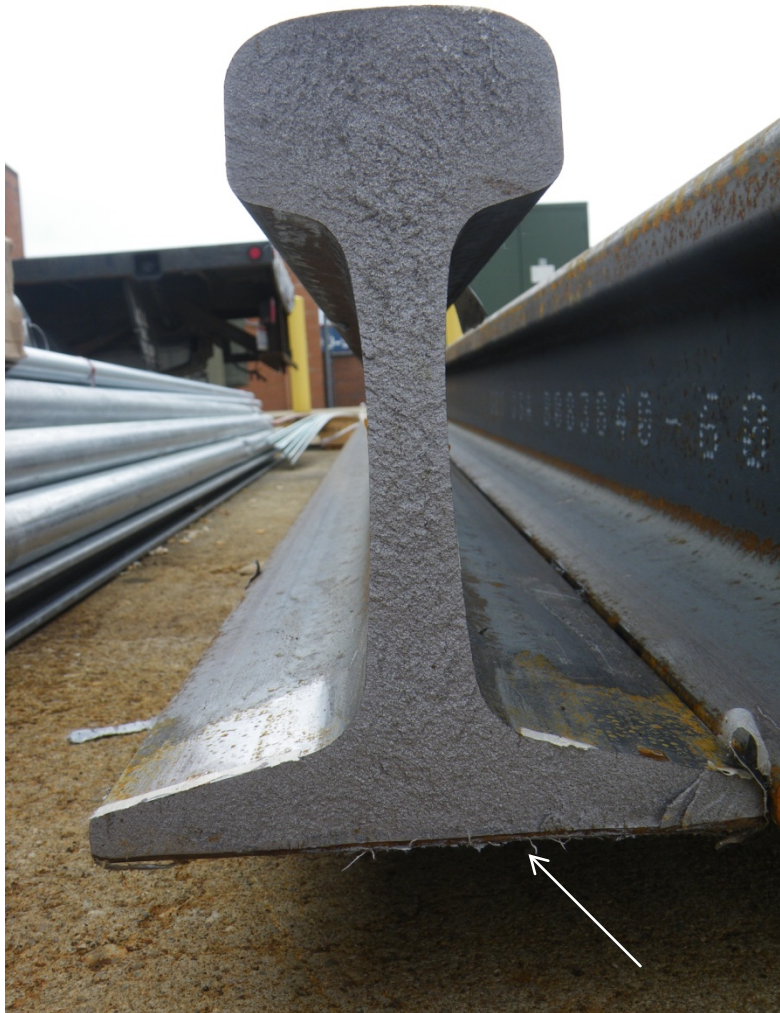
**Figure 39. Resonant Fatigue Fracture Surface of Unprotected, Corroded Rail (Sample RS3)
Arrow Shows Crack Zone**

Fatigue results are judged partly based on the range of stress loading. Since the cycles provide reversed loading, the stress ranges will be twice the values given in Table 10, or roughly 60–80 ksi. Sample RS1 was tested without a notch and at a higher stress range than the notched rails. Failure of that sample was not induced in the testing. Samples RS2–RS5 were pre-notched before treatments, corrosion cycles, or testing. RS2 was not protected from corrosion, but it also did not see purposeful corrosion cycles. Sample RS3 was unprotected, but *did* undergo corrosion cycling and had a saltwater solution “diaper” applied during resonant fatigue. It could represent older rail in service that had somehow been damaged and suffered corrosion attack. It failed in the crack zone, but showed slightly higher fatigue life despite the corrosion and lack of protection. Rust formation is clearly evident in the failure zone of RS3 (Figure 39).

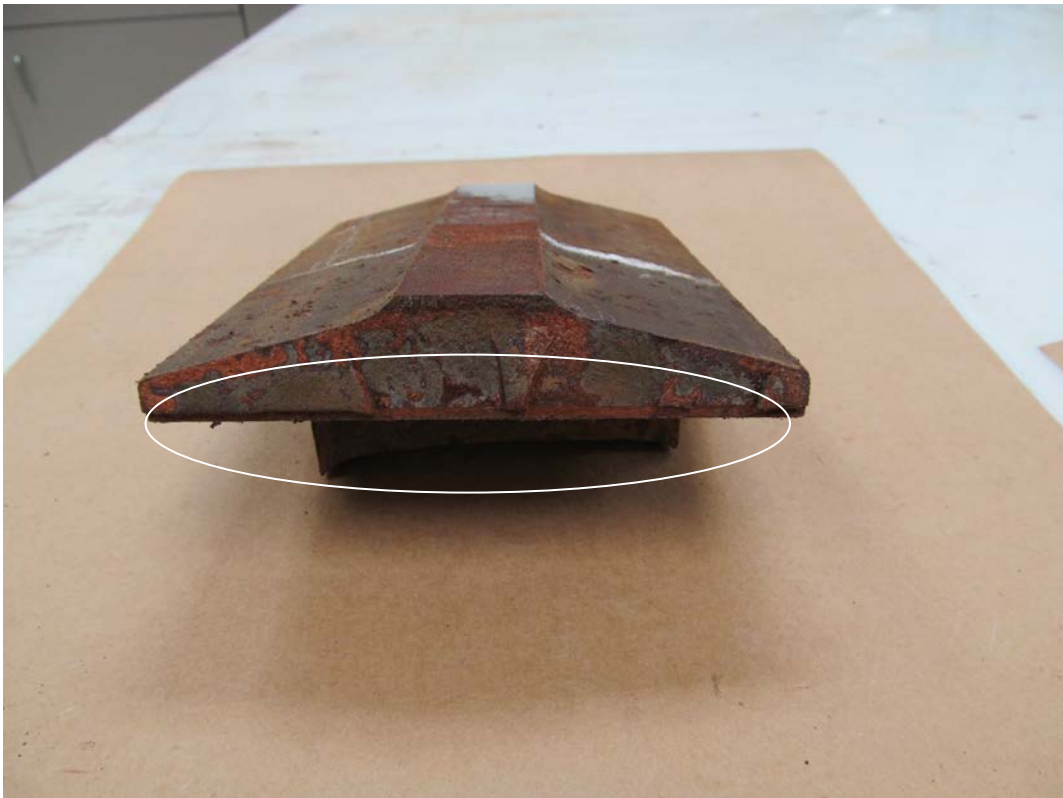
Figure 40. Fracture Surface of Corroded Sample with No Protection (Crack – corrosion area is circled)

In comparing the character of the fracture surfaces with those for the medium-scale samples, the resonant fatigue samples showed much smaller regions of fatigue cracking than those visible on the medium-scale samples (Figure 40 and Figure 41, tested in Task 3). This difference is attributed to the larger cross-section of the full rail inducing a higher stress intensity factor in the rail at the fatigue crack tip, allowing brittle fracture to take over from fatigue at a smaller crack size.

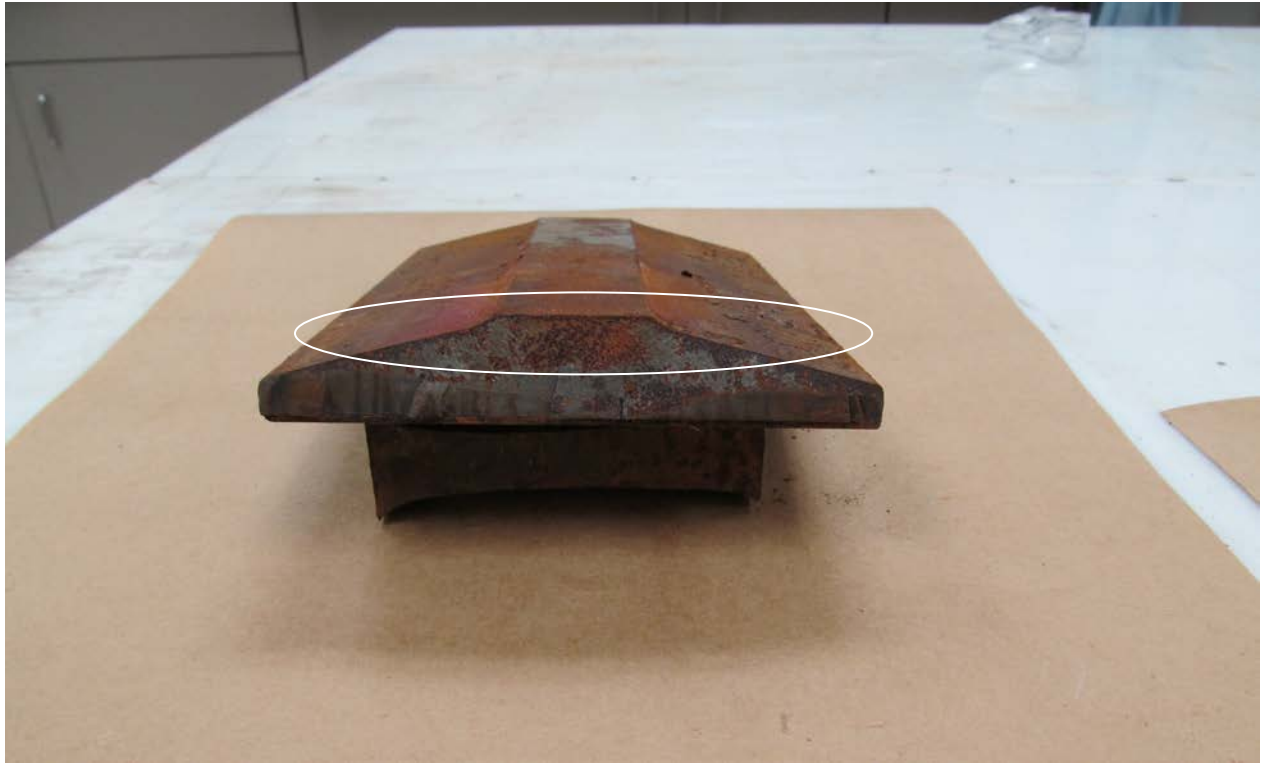
Figure 41. Fracture Surface of Corroded Sample with ALL Treatment

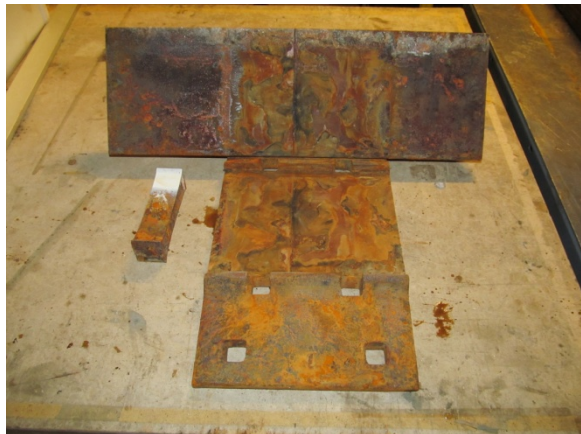
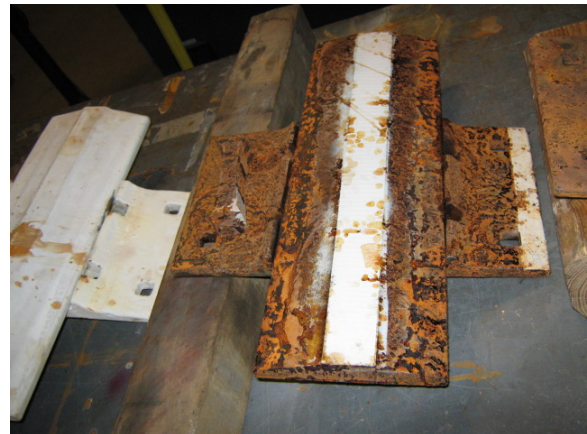
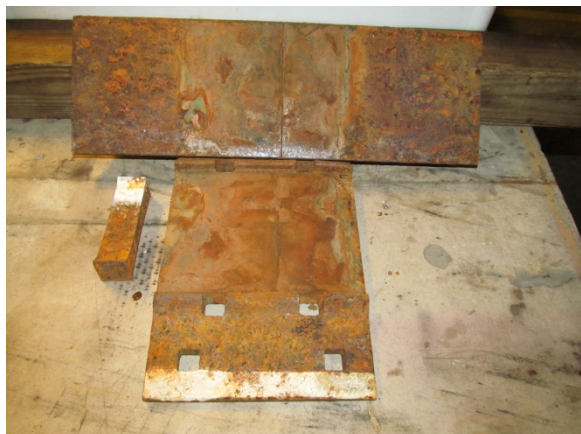
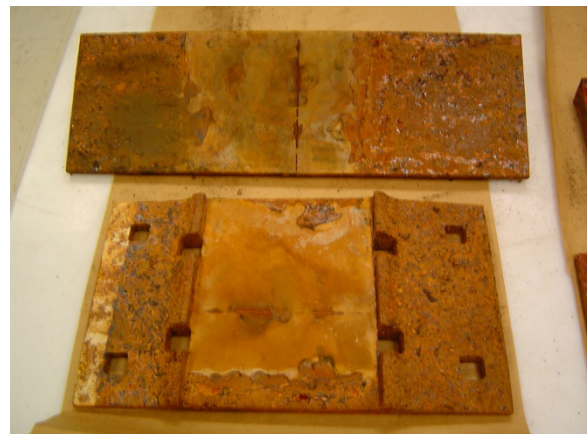
Fig. A-1. Week 1 – PD after Salt Water

Fig. A-2. Week 1 – PD after Humidity

Fig. A-3. Week 2 – PD after Salt Water

Fig. A-4. Week 2 – PD after Humidity

Fig. A-5. Week 3 – PD after Salt Water

Fig. A-6. Week 3 – PD after Humidity

The sequential progress of corrosion is shown pictorially in Appendix A. A synopsis follows. At the end of the 3-week corrosion exposure, the PD, ALL, and untreated samples were corroded in varying degrees while the EonCoat® system showed virtually no corrosion (Figure 30 through Figure 33). The bottoms of the flanges and the tops of the tie plates are shown.

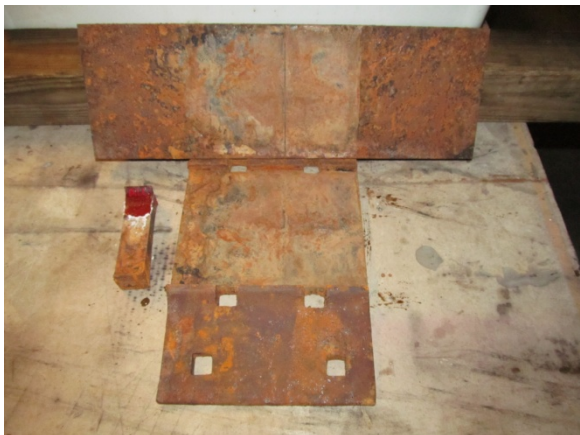
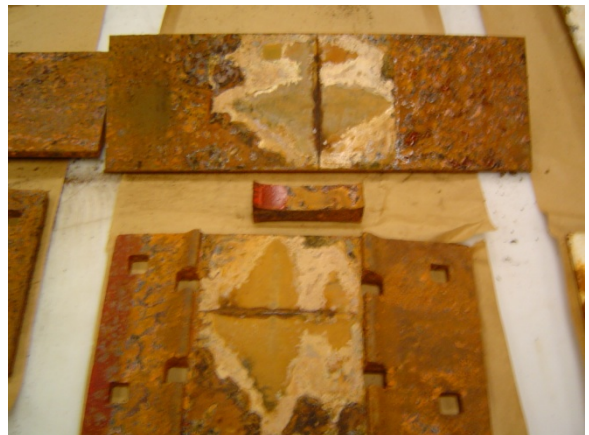
Fig. A-7. Week 1 – ALL after Salt Water

Fig. A-8. Week 1 – ALL after Humidity

Fig. A-9. Week 2 – ALL after Salt Water

Fig. A-10. Week 2 – ALL after Humidity

Fig. A-11. Week 3 – ALL after Salt Water

Fig. A-12. Week 3 – ALL after Humidity

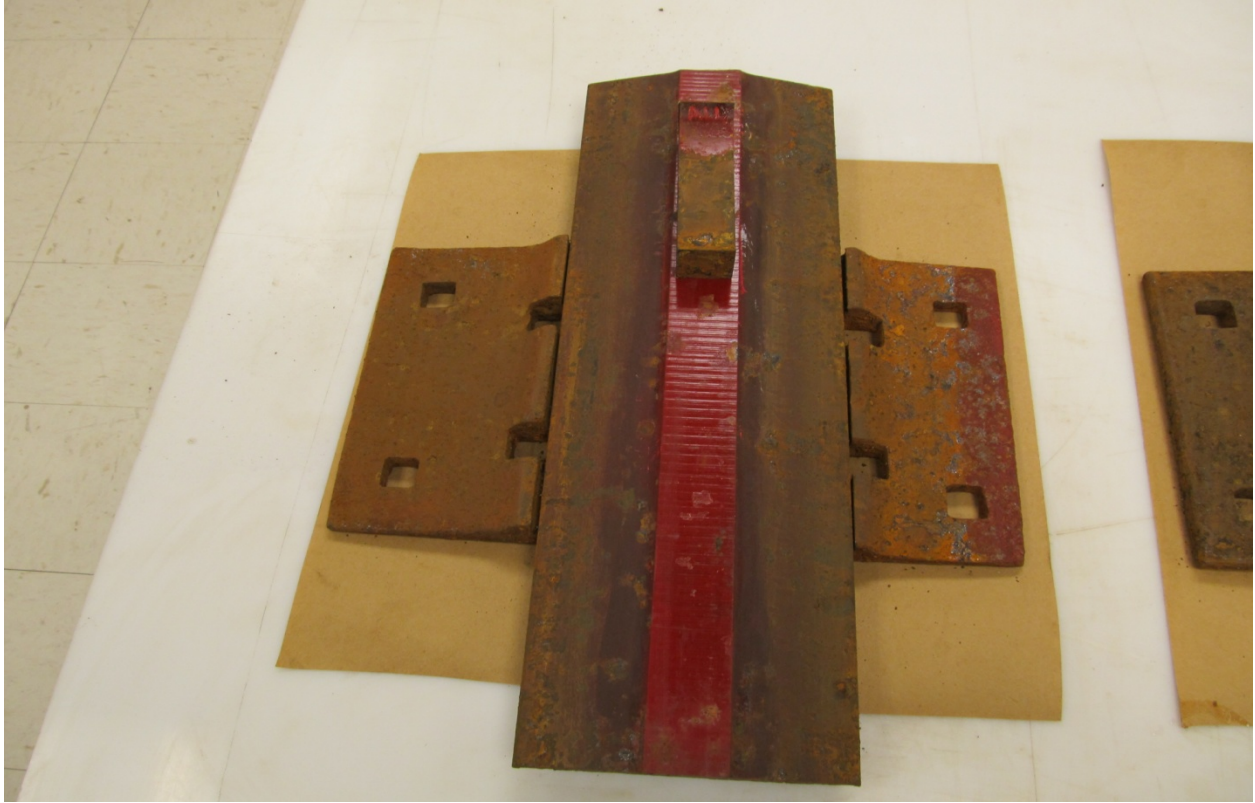
Figure A-25. ALL after Cleaning

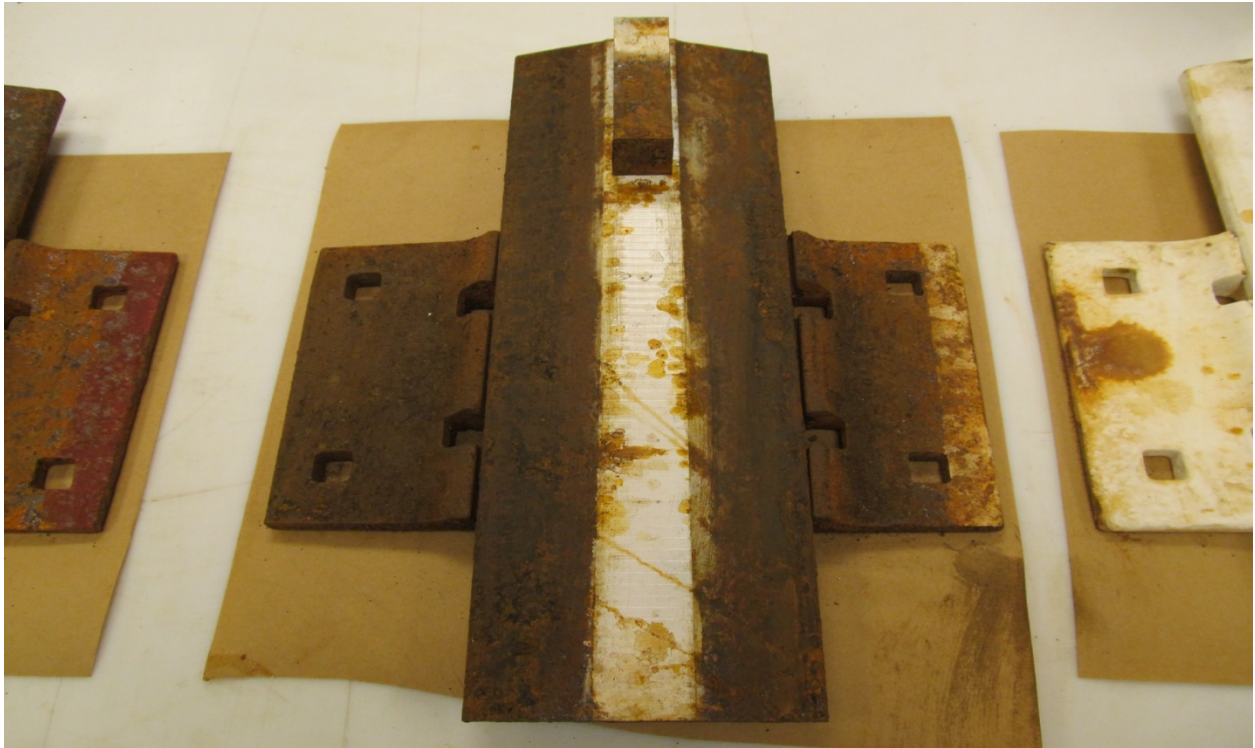
Figure A-26. PD after Cleaning

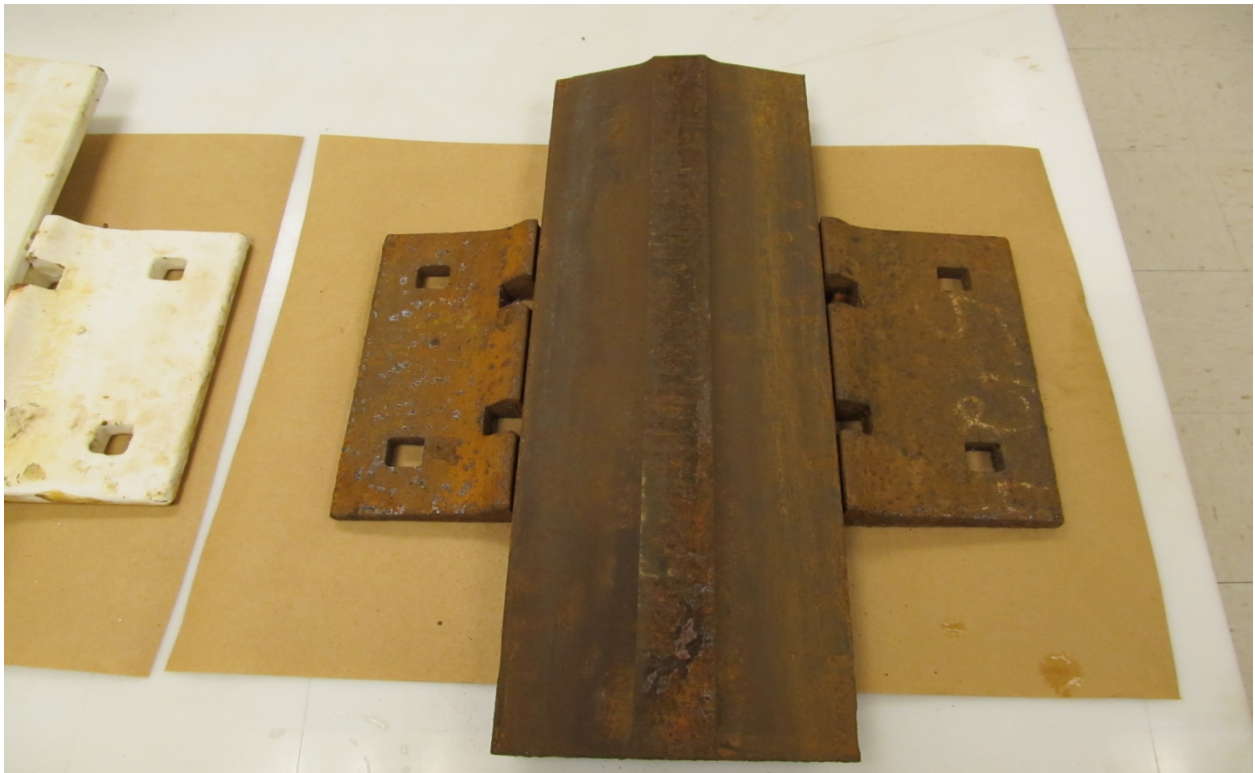
Figure A-28. No Treatment, after Cleaning
