EonCoat Corrosion Protection

Federal Railroad
Administration (FRA) Rail
Base Corrosion & Cracking
Prevention Study

Rail Base Corrosion and Cracking Prevention

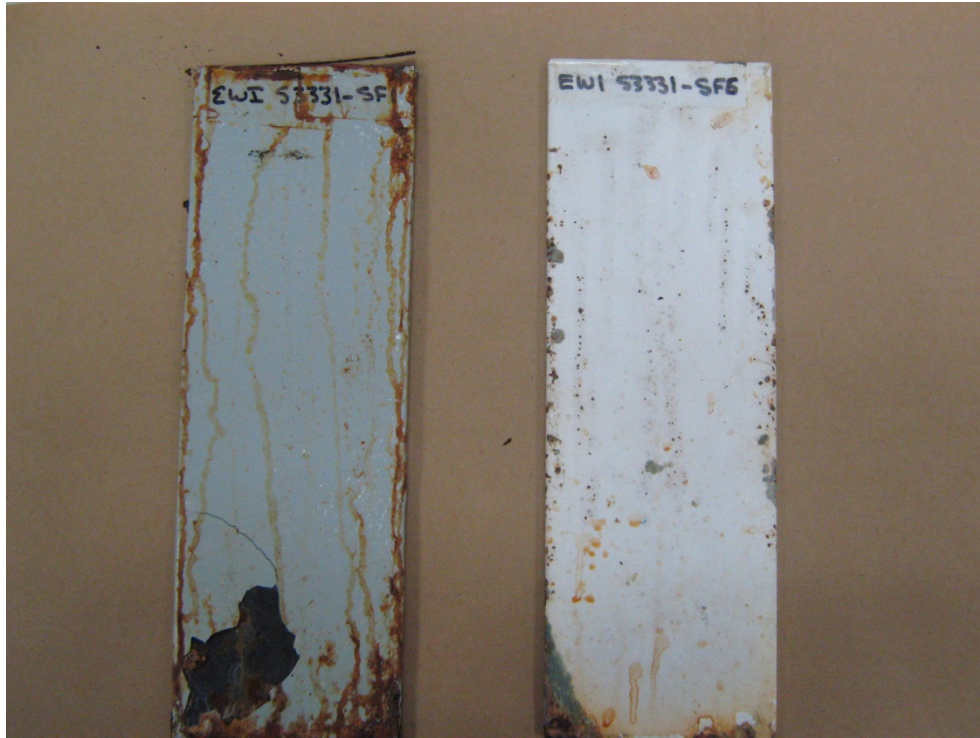
Figure B-3. EWI (left) and EonCoat® (right) after 5,000 Hours, Back Side

The progression of front, scribed side attack on the EWI system is shown in Figure B-4. Once the primer is destroyed, it does not function effectively. The back side for EonCoat® shown at 500 hours and 5,000 hours in Figure B-5 shows the possible onset of progressive loss in effectiveness. However, the overall protection appears to be quite good.

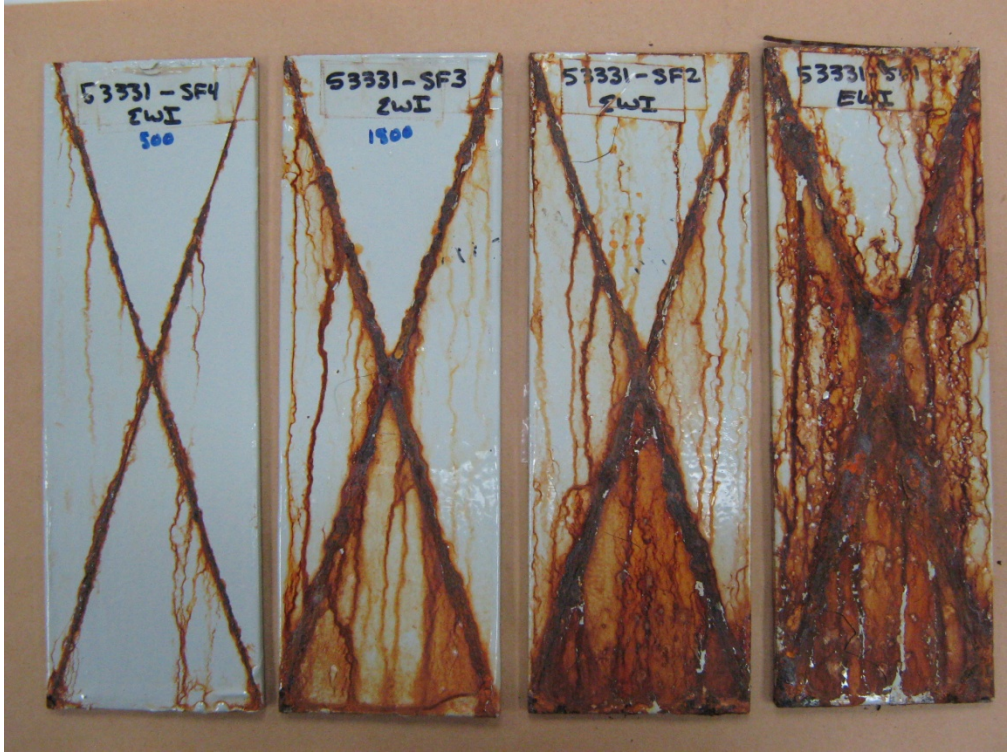
Figure B-4. EWI, Scribed to Metal. L→R: 500, 1500, 3000, 5000 Hours

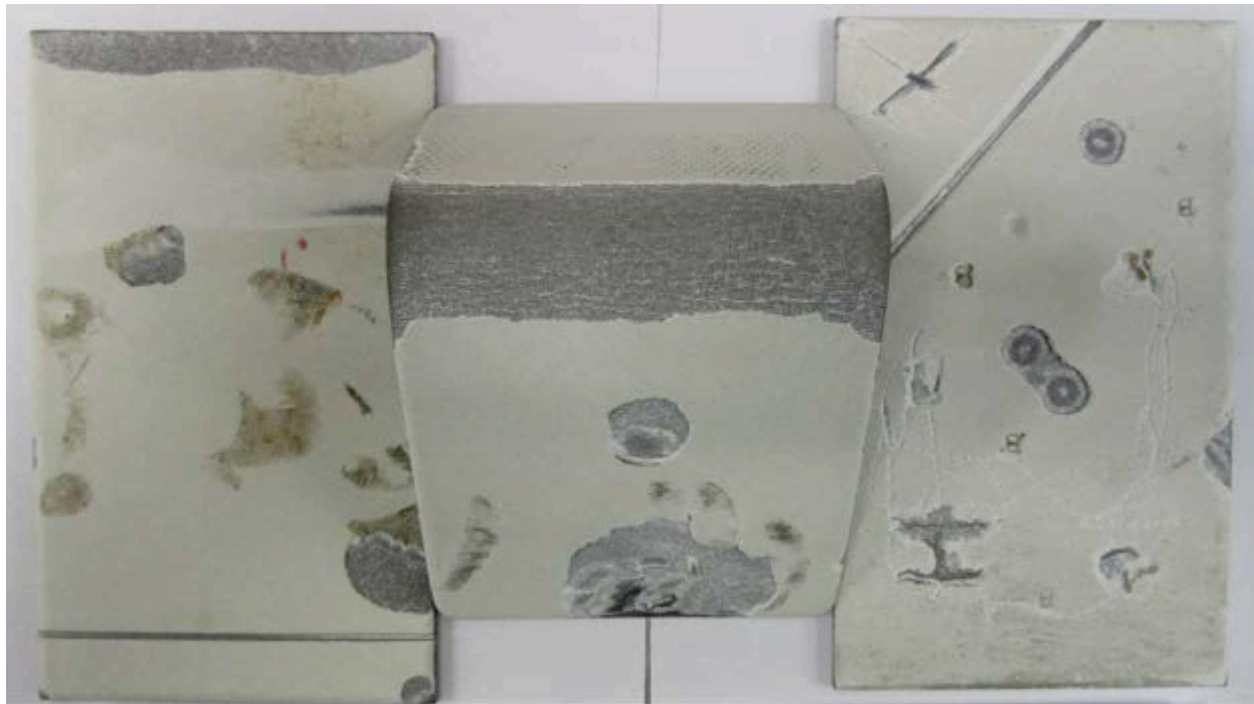
Figure 1 – EonCoat panels with intentional mechanical damage.

To test the mechanical integrity of EonCoat, panels were intentionally damaged. Damage was inflicted in a number of different ways – (i) Impact damage with a ball being dropped on the panel, (ii) The panel was dropped from a height of 3-4 meters onto the cement, (iii) A saw blade was used to make a cut like mark in the protective layer (but not cut through the steel itself), (iv) Various hardness tests (designed to inflict mechanical damage) were done on the panel, and (v) A mechanical polisher was used in some areas. In the most extreme case, one of the panels was bent at a 90° angle. This bend did bring new steel to the surface. Figure 1 shows the panels after damage and before B117 exposure.

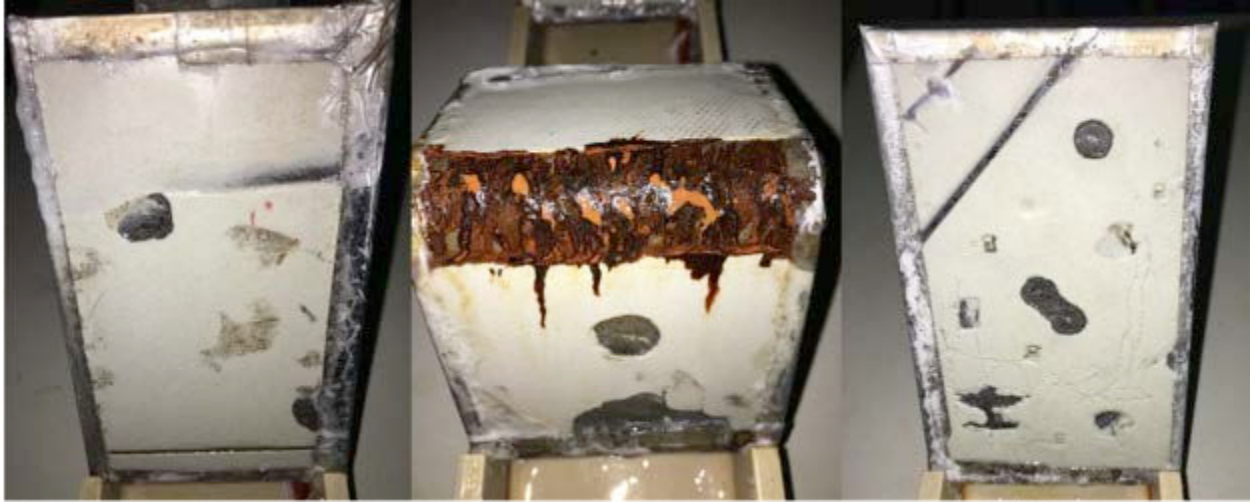
Figure 2 – EonCoat panels with intentional damage after 335 hours of B117 exposure.

Then the panels were subjected to ASTM B117 conditions; the figures show the duration time for the panels. In the pictures below, we show the panels before B117 testing and then after 335 hours (Figure 2) and after 1,870 hours (Figure 3). In all cases, there is not rust in the areas where the panels were intentionally damaged, aside from the 90° bend in the panel. Again, the panels show no sign of rust. Organic coating would have failed to control the corrosion in these conditions.

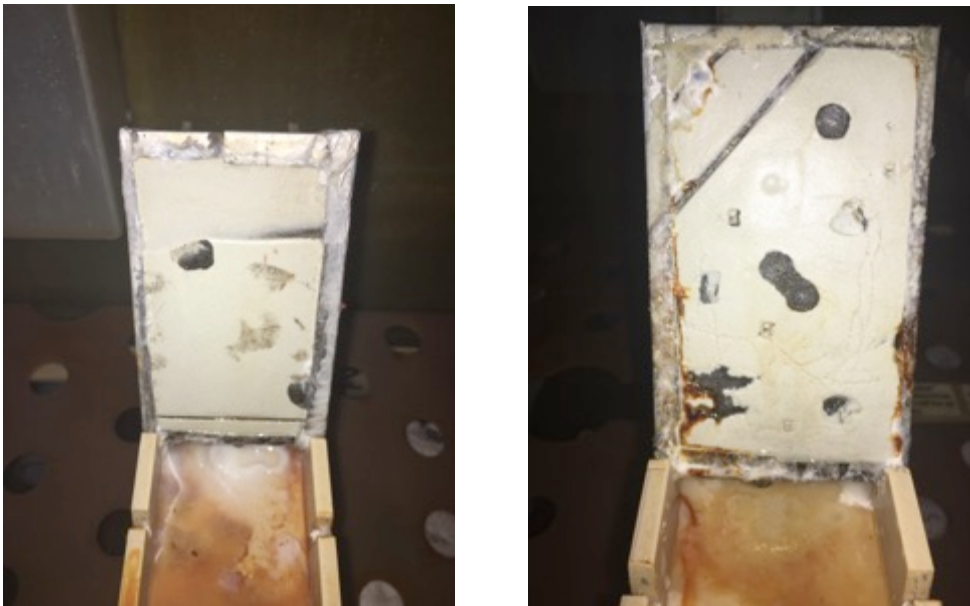
Figure 3 – EonCoat panels with intentional damage after 1,870 hours of B117 exposure.

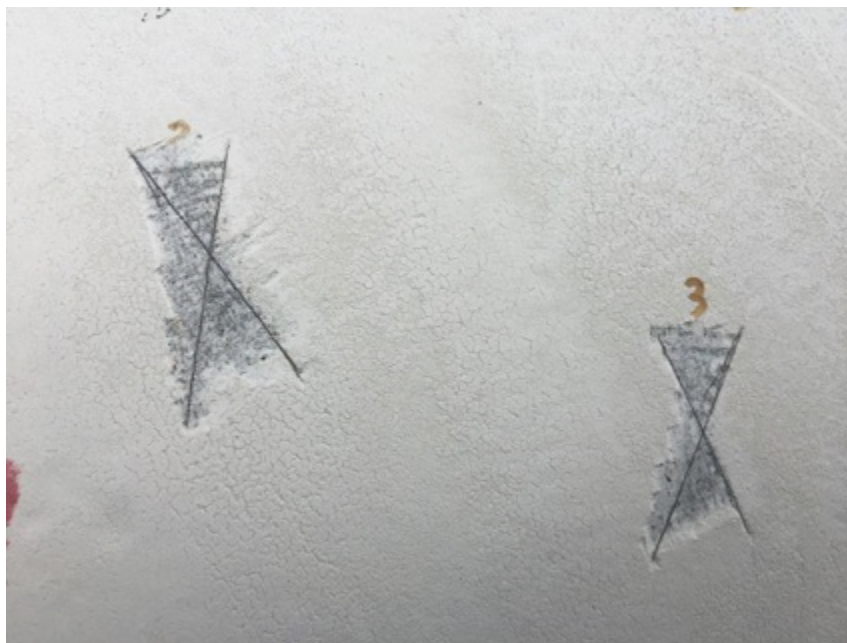
Figure 4 – Cross-cut adhesion of EonCoat – June 2018 after 4 months of being insulated and in service.

Field-testing of EonCoat in CUI conditions continues. Figure 4 (below) shows cross-cut adhesion into the coating. The cross-cut adhesion was performed in February 2018 and then re-examined in June 2018, 4 months later. The picture in Figure 4 shows the cross-cut and subsequent removal of adjacent phosphate ceramic. This picture was taken in June 2018 after the pipe had been placed back in service. The pipe service, insulated with blankets, is running at temperatures ranging from 120 to 138 °C.

Like the intentionally damaged panels above, again, the EonCoat shows no rust. Organic coatings would have begun to show corrosion.

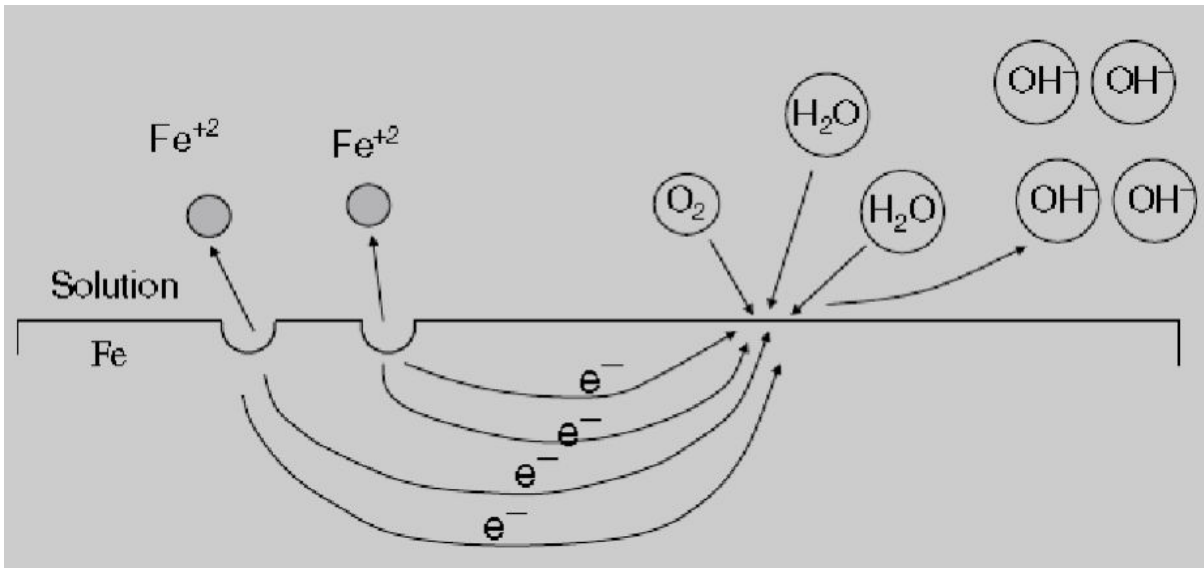
1. **cathodic site** (where electrons are consumed);
2. **anodic sites** (usually where corrosion occurs). Both sites can be on the same piece of metal;
3. cathode and anode are connected through the solution by **an ionic current pass**;
4. and they are connected through the metal by **an electronic path**.

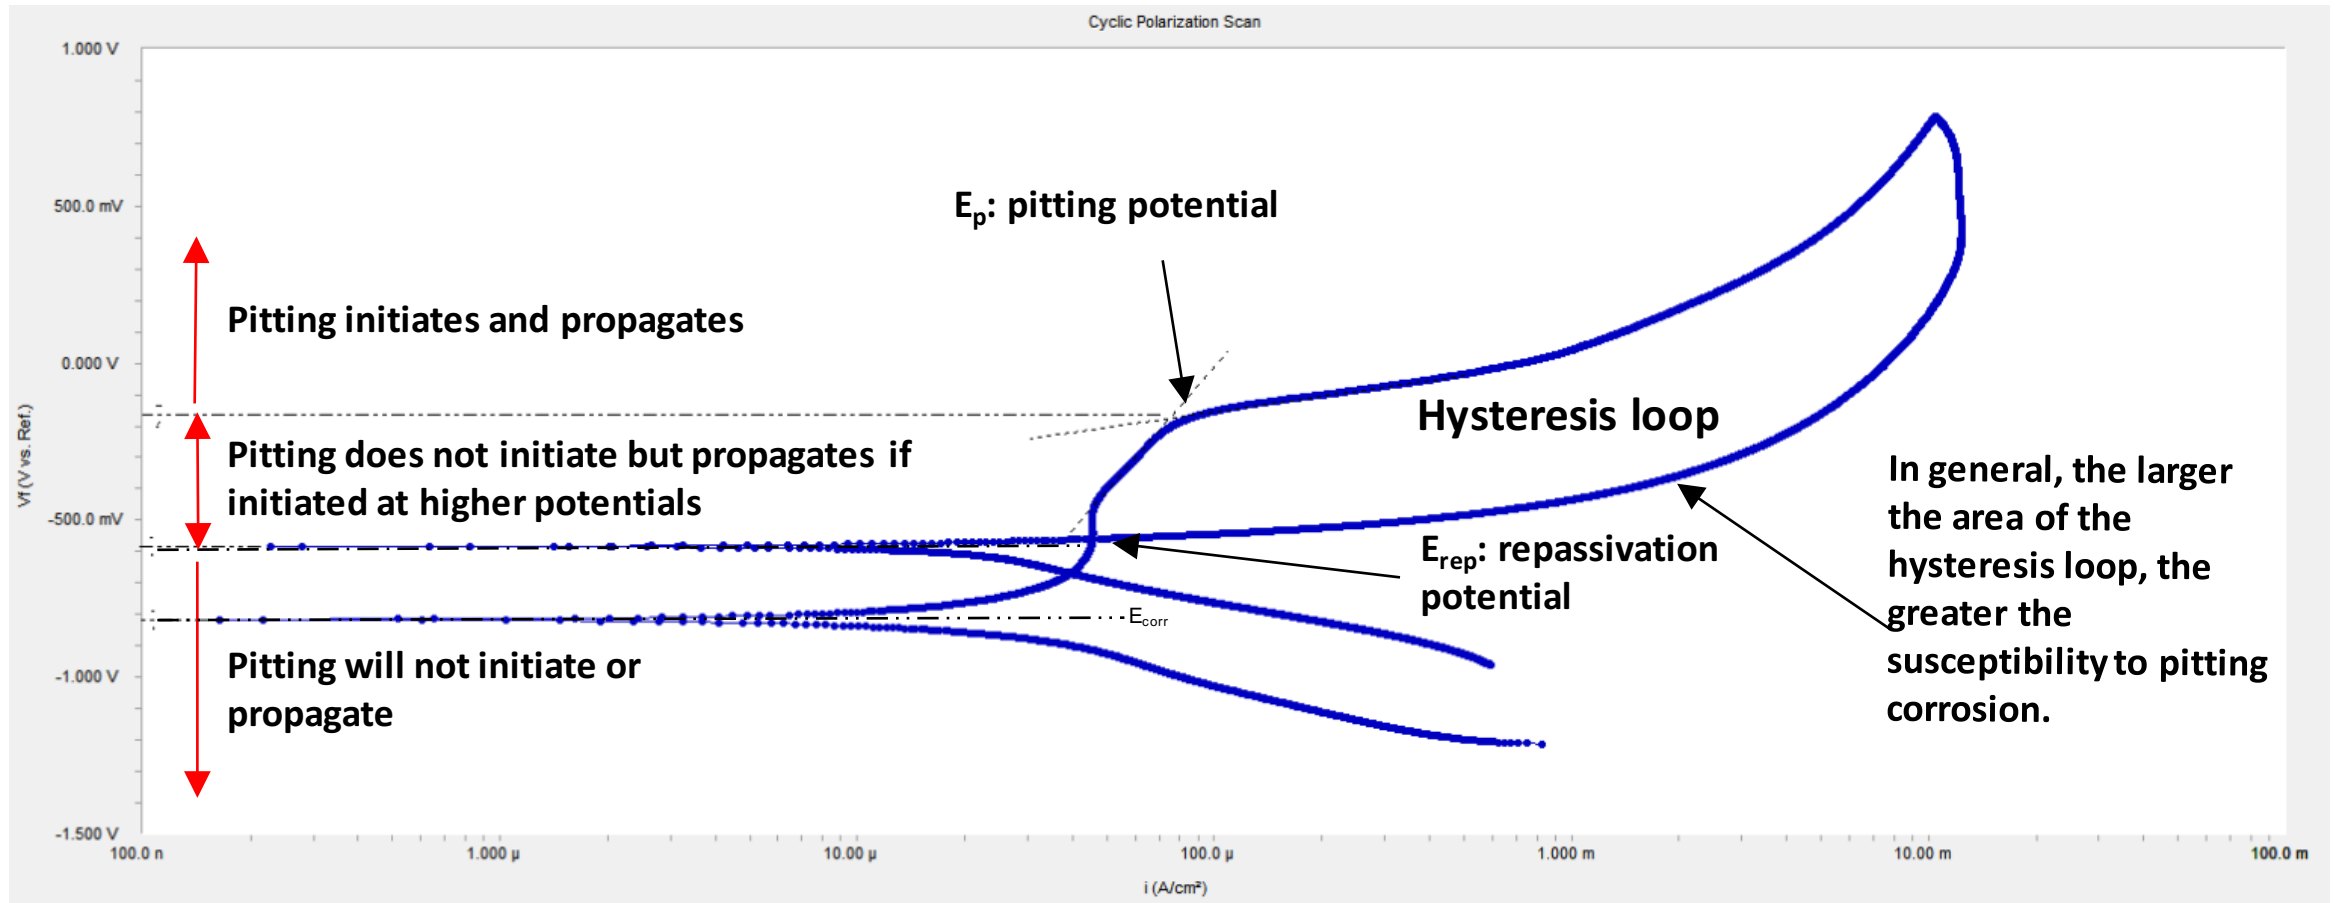
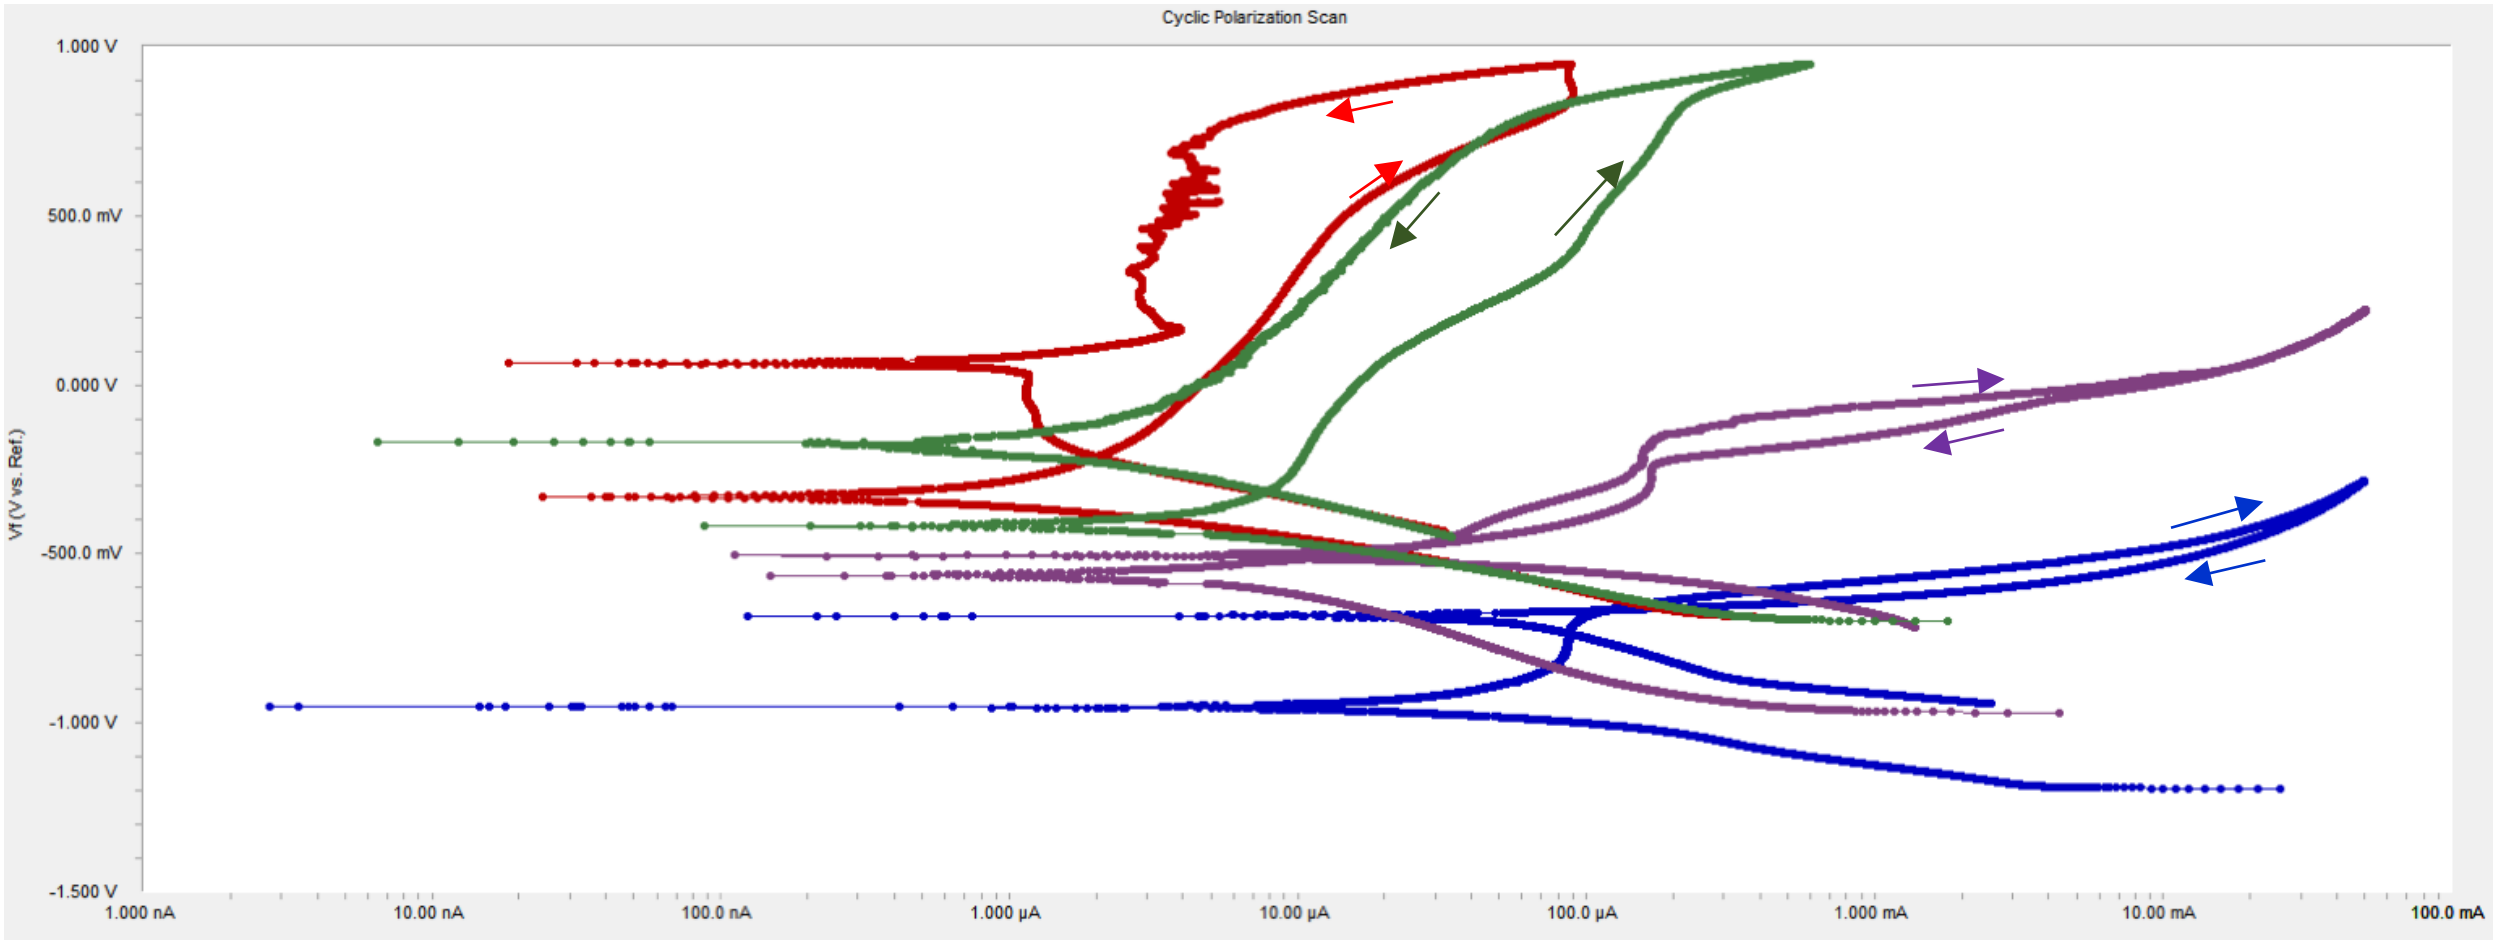
Cyclic polarization curve for Eoncoat (green) in comparison with mild steel (blue), stainless steel 304 (magenta) and Hastelloy (red). Arrows show directions of forward and backward sweeps.

HOW TO INTERPRET A CYCLIC POLARIZATION CURVE
