Effects of Combined Corrosion and Fatigue on Rail Performance

The Manufacture Innovation
Effects of Combined Corrosion and Fatigue on Rail Performance
AREMA - 2013
Dr. George W. Ritter, Principal Engineer, EWI Dr. William C. Mohr, Principal Engineer, EWI Cameron D. Stuart, Program Manager, FRA Dr. David Y. Jeong, Mechanical Engineer, Volpe NTS Center Yim Har Tang, Mechanical Engineer, Volpe NTS Center
Technology Center Technology Center
ARCINANS September 29 - October 2, 2013 ANNUAL CONFERENCE September 29 - October 2, 2013

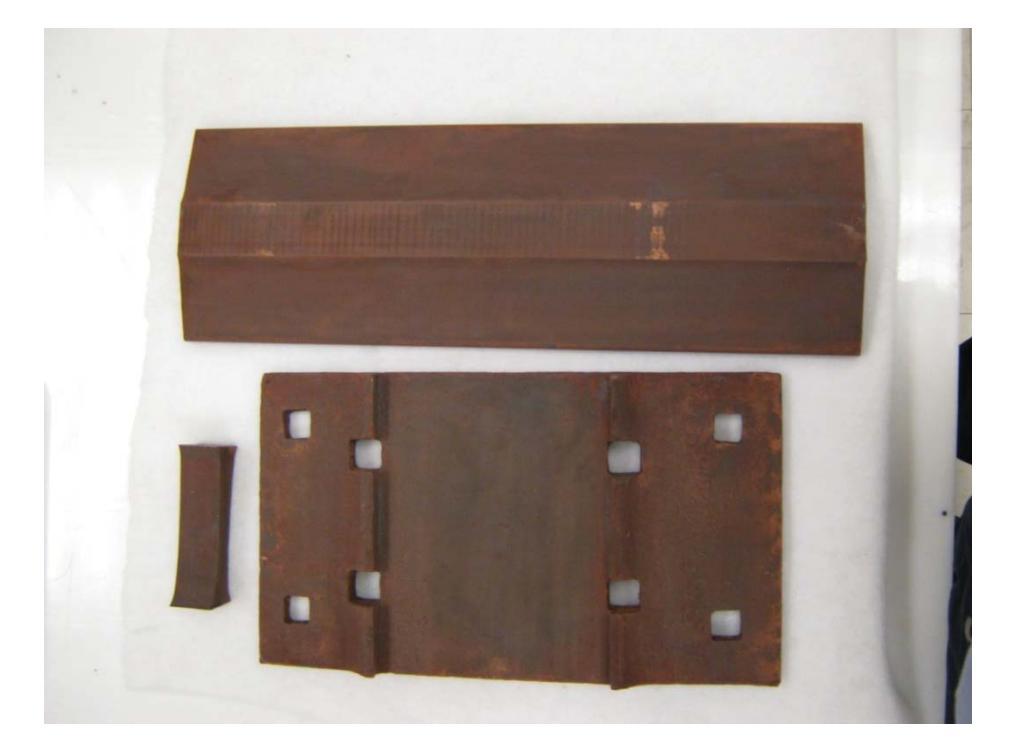
A treated tie plate, flange base, and small witness coupon are shown as treated in Figure 2. For the corrosion cycles, the flange piece was nested into the tie plate to simulate a corrosion antagonist trapped between the rail and the tie plate.

Figure 2. Specimens Treated with the EWI Three-Step Process after Baking

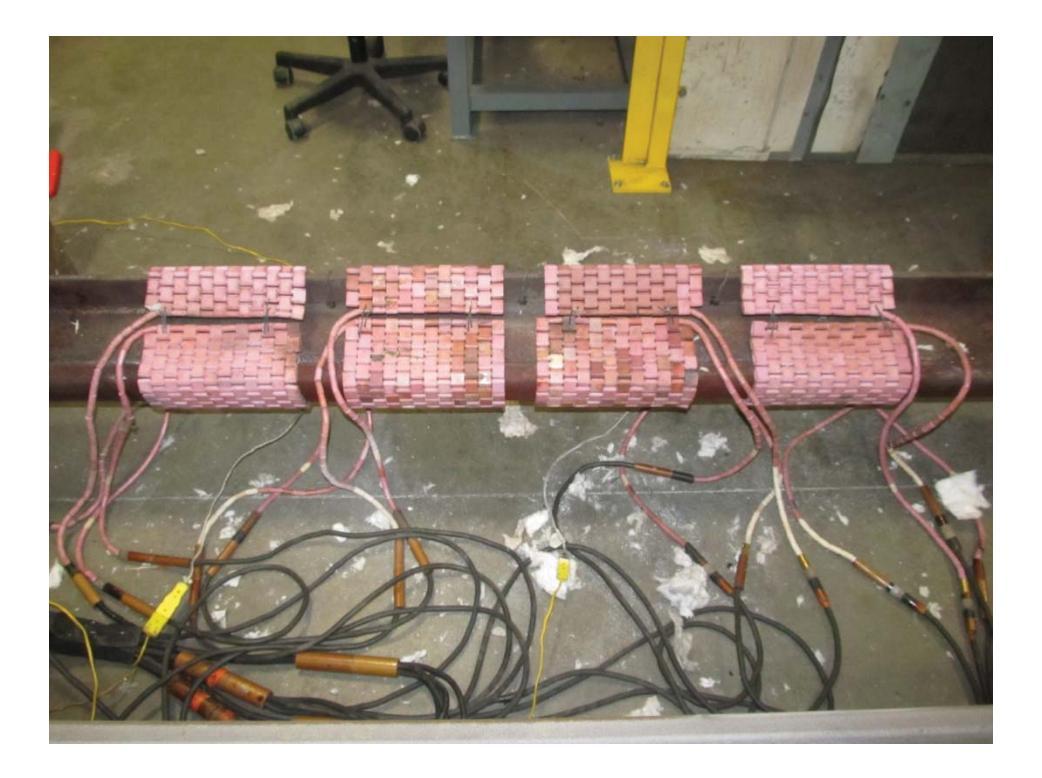
Figure 3 shows a rail segment that has been treated with the three-step process and is wrapped with heater blankets prior to the bake cycle. An insulating layer of ceramic fiber blanket was then placed over the heating area. In practice, the rail outside the heating zone stayed quite cool.

Figure 3. Resistance Heating Blankets used to Heat Cure the Zirconia Sol-Gel Sealer

In the three-step process, for the final bake, the medium-scale specimens were heated in a muffle furnace. Large rail sections were heated using resistance heating blankets for welding. There is a variant using only the first two steps where the the zirconia sol-gel and baking cycle are eliminated. That two-step approach was also tested for effectiveness.

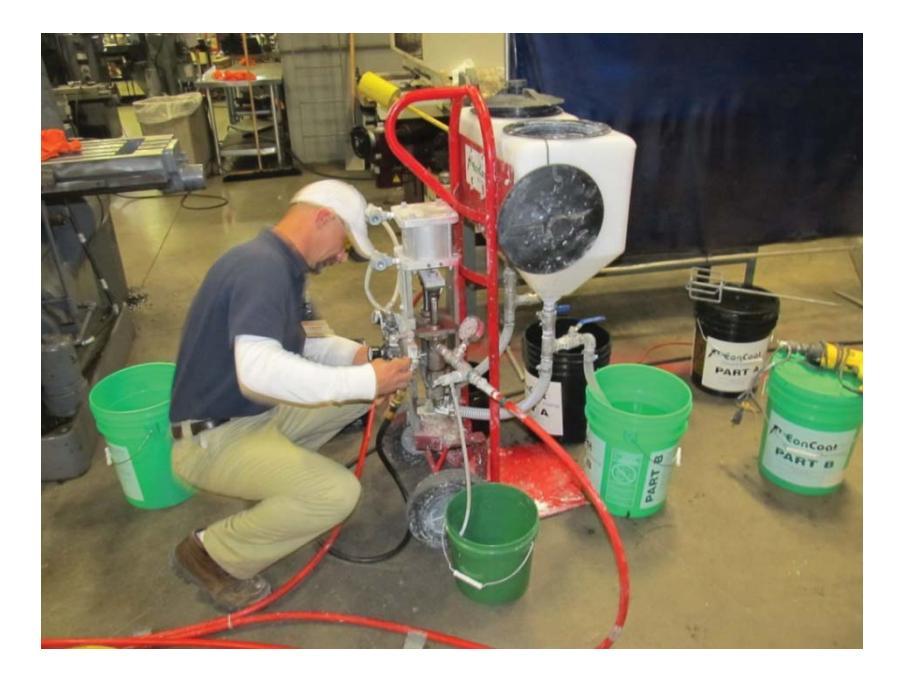
EonCoat® is a commercially spray-applied ceramic coating (4). The overall formulation is proprietary. Standard two-component spray equipment is used with a mixer-head nozzle (Figure 4). It dries within minutes of application. A second coat can be applied in about 10-15 minutes, which was the practice used here. Smaller flange segments were treated at EonCoat® by the manufacturer. A large rail segment was spray coated at EWI by EonCoat®. That rail segment is shown in Figure 5. There is evidence of some debonding of the spray at the edges (circled in Figure). These areas are outside the regions that had excess rust removed by grinding.

Figure 4. Technician Readies the EonCoat® Applicator System

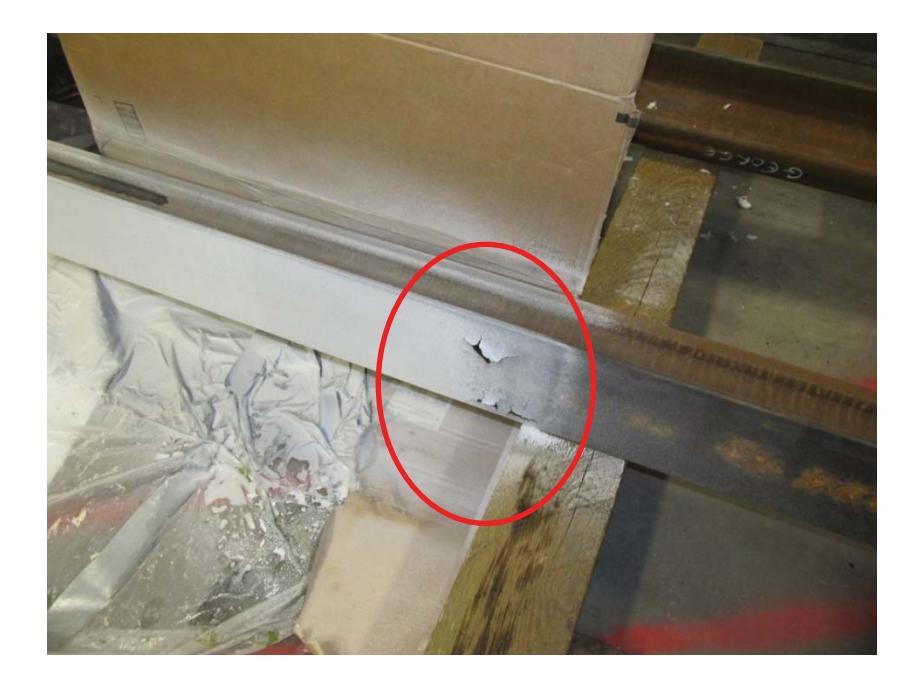
Figure 5. EonCoat® Sprayed Rail Segment

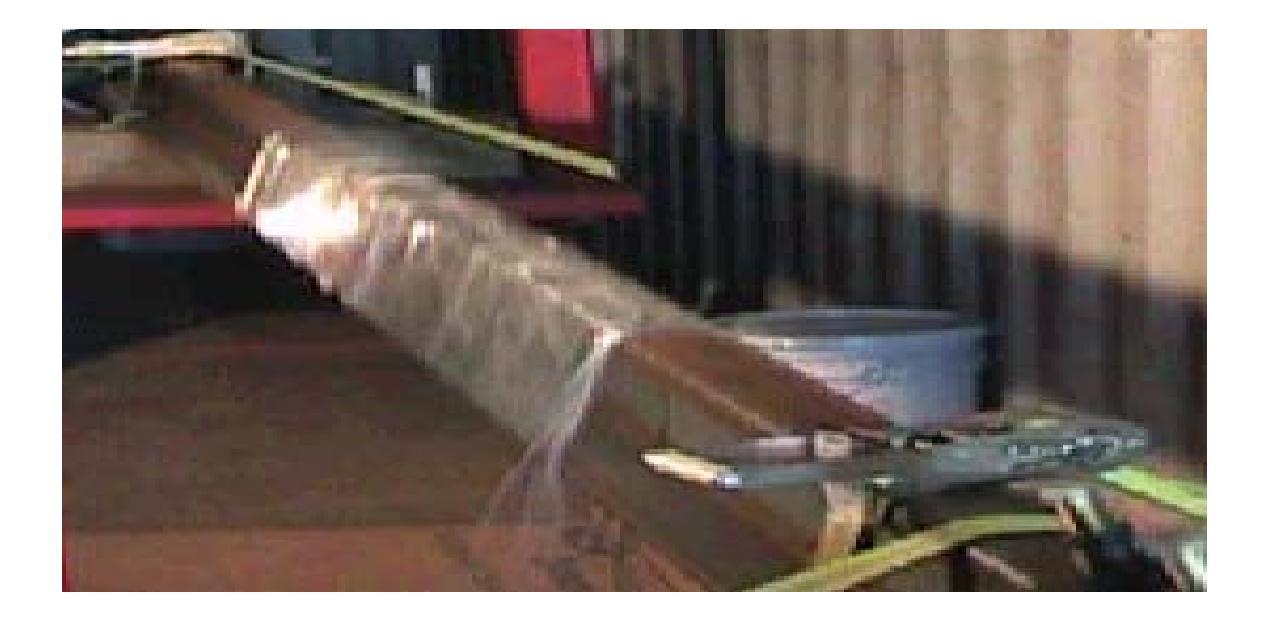
In this method, the rail is suspended between two support points. A counterweight of calculated size is attached to one end. The correct excitation, provided by an eccentric drive cam at the opposite end, forces the rail into self-resonance around the center point. Strain gauges monitor the cyclic strains at several locations on the part. At some point, a crack will grow to sufficient size to cause the rail to yield. This is the failure point at which the machine stops and the cycles to failure are noted. In this case, the rail was excited to give a self-resonance at about 21 Hz. The excitation and self-resonance induce a stress on the rail head of 28-30 ksi and a stress on the rail base of 25-26 ksi. An example of a loaded test article is shown in Figure 6.

Figure 6. Rail Suspended in Resonant Fatigue Apparatus

The twenty-foot rail sections were used for testing using a fatigue method called *resonant fatigue*. Resonant fatigue methodology has been most commonly applied to testing of welds in drill pipe. It has been adapted at EWI for use also on rail segments.

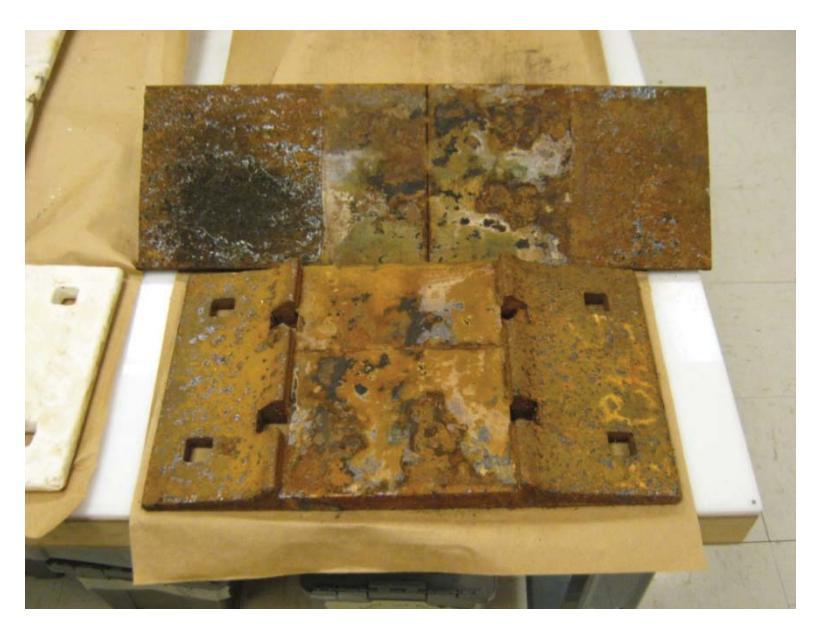
Figure 7 shows the un-protected specimen after corrosion, Figure 8 shows the threestep treated specimen after corrosion, and Figure 9 shows the EonCoat® specimen after corrosion.

Figure 7. Unprotected Flange and Tie Plate after Cyclic Corrosion

The unprotected specimen clearly has undergone severe corrosion. The threestep protection system shows good protection in the notch zone, but corrosion is beginning to creep in from the edges. Based on visual examination, the EonCoat® system has provided the best corrosion protection. A "drip zone" is a region where rail would be exposed to condensing water, but not necessarily saltwater, that might drip from an overpass, for example. A drip-zone specimen, protected on the bottom half with the three-step method, is shown in Figure 10. The corrosion cycle for drip zone testing also lasted three weeks, but instead of saltwater soaks for two days, the specimens spent an additional two days in the humidity cabinet, producing a total of five days of humidity each week broken into twoday and three-day segments.

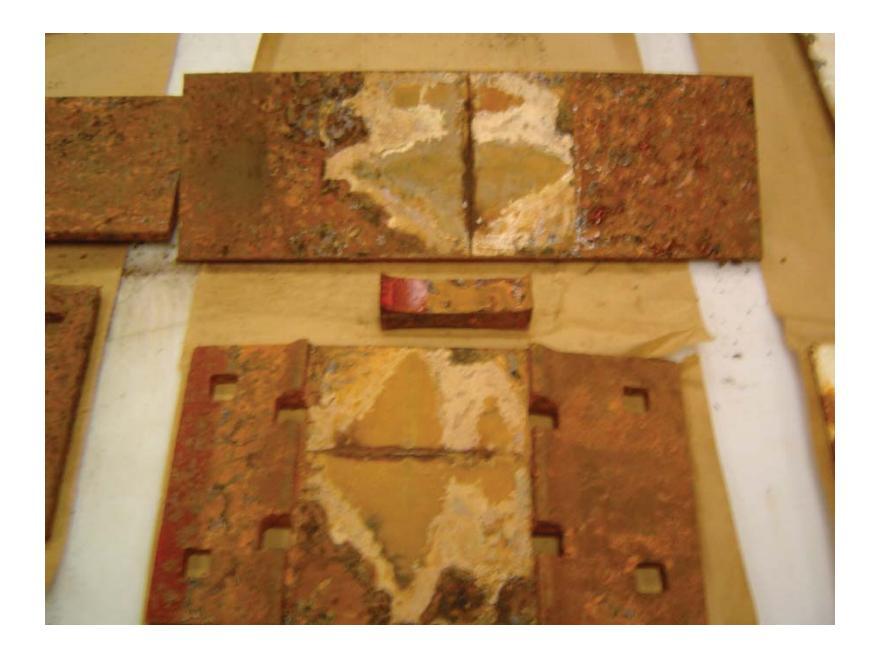
Figure 8. Three-Step Treated Flange and Tie Plate after Cyclic Corrosion

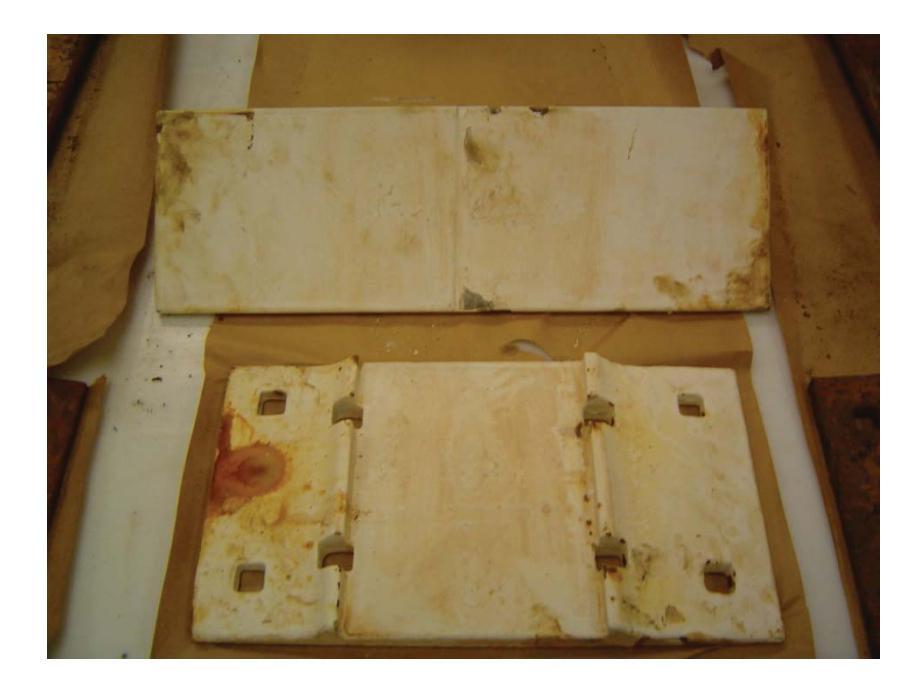
Figure 9. EonCoat® Treated Flange and Tie Plate after Cyclic Corrosion

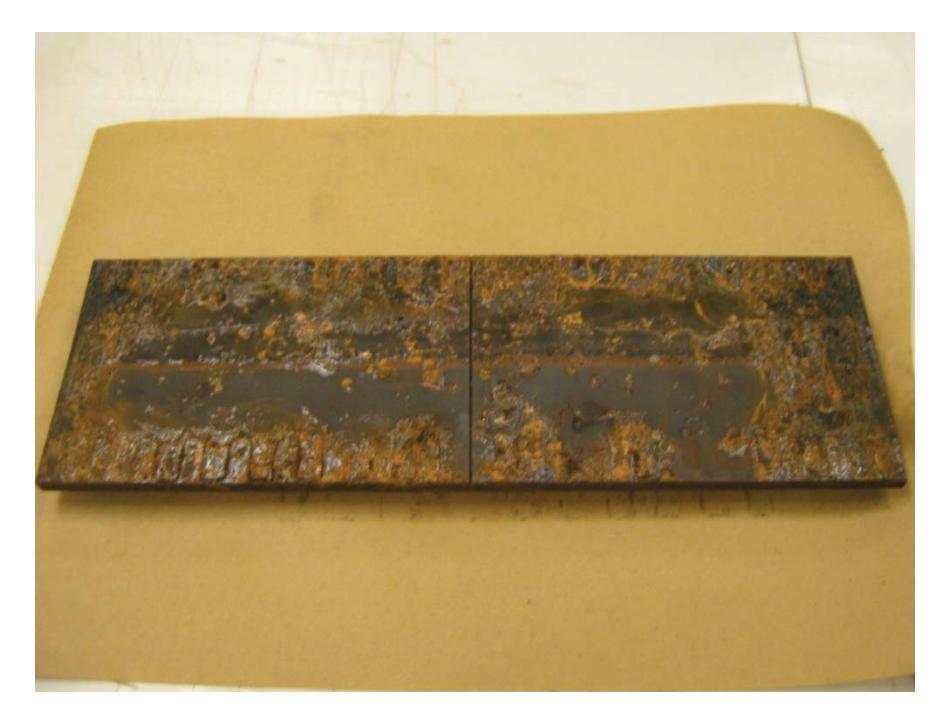
Figure 10. Bottom of Treated Drip Zone Specimen

The bottom half of the flange base is the treated portion. The top, untreated portion has completely evolved into rust. The bottom portion shows invasive rust from the lower edge but is also that invasion was less over the exposure time period. While complete protection has not been afforded, there has been retardation of rusting.

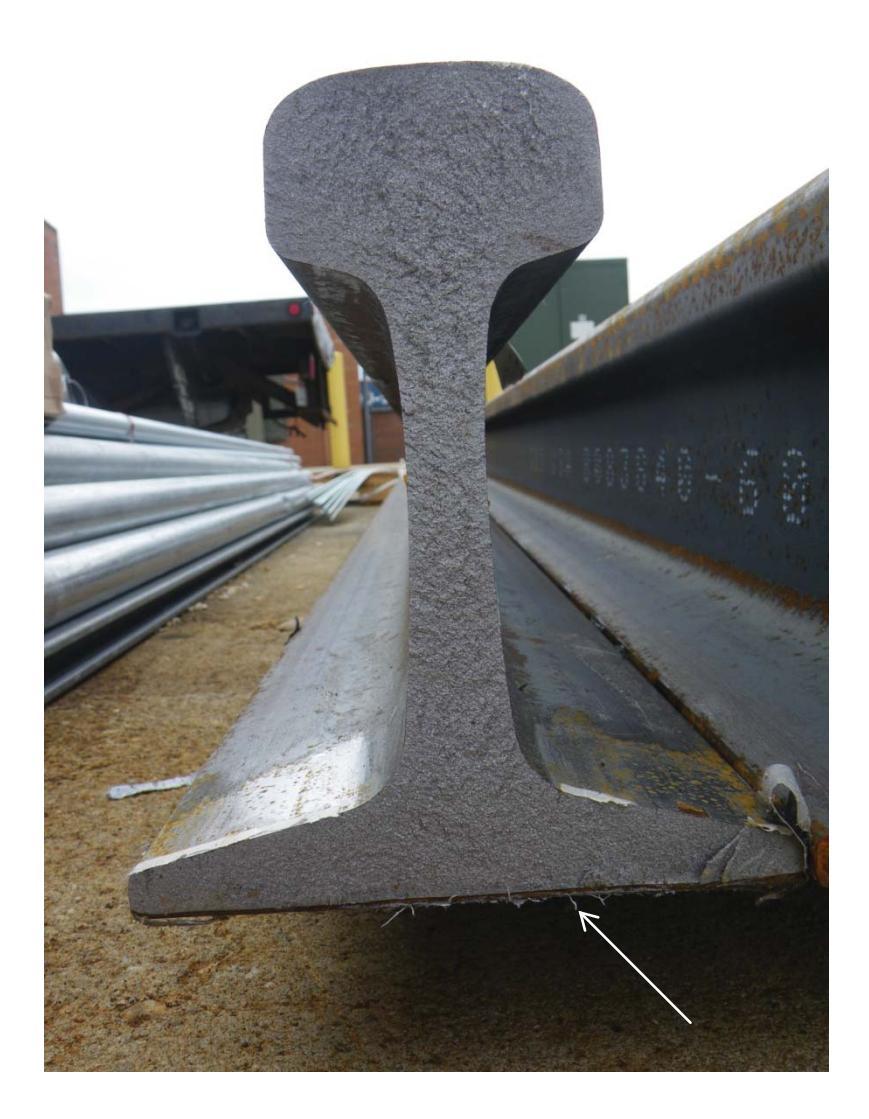
Specimens RS1 – RS4 were pre-notched before treatments, corrosion cycles, or testing. Therefore, the notched zone saw the same corrosion history as the rail itself. RS1 was not protected from corrosion, but it also did not see purposeful corrosion cycles. Sample RS2 was unprotected, but *did* undergo corrosion cycling and also had a saltwater solution "diaper" applied during resonant fatigue. It represented older rail in service that had somehow been damaged and suffered corrosion attack. It failed in the crack zone, but showed slightly higher fatigue life despite the corrosion and lack of protection. Rust formation is clearly evident in the failure zone (Figure 11).

Figure 11. Resonant Fatigue Fracture Surface of Unprotected, Corroded Rail (Sample RS3)

In comparing the character of the fracture surfaces with those for the mediumscale specimens, the resonant fatigue specimens showed much larger regions of fatigue cracking than those visible on the medium-scale specimens. This difference is attributed to the larger cross-section of the full rail inducing a higher stress intensity factor in the rail at the fatigue crack tip, allowing brittle fracture to take over from fatigue at a smaller crack size.

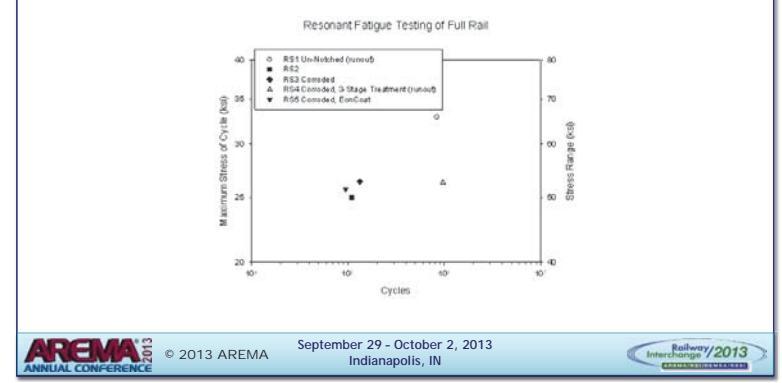
Results from Resonant Fatigue

No clear correlation found with damage, protection level, or corrosion
