TANK BOTTON CORROSIONESOLVED

Merrick Alpert, EonCoat, USA, describes how a weldable coating has been designed to protect welded tank bottoms from corrosion.

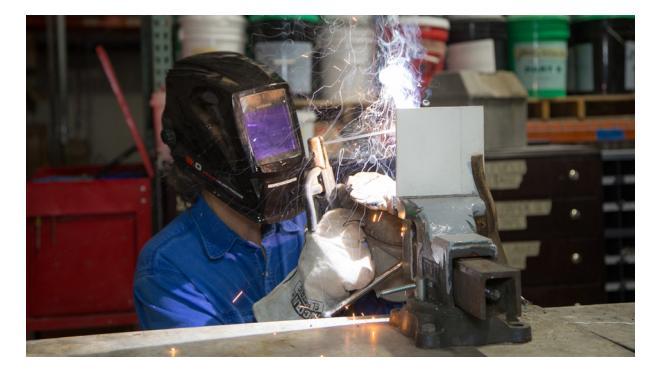
Figure 2. Two plates coated with EonCoat weldable coating being welded together.

Unlike traditional polymer coatings that burn up when welded, EonCoat is inorganic and non-flammable. Made entirely of minerals, the coating will not burn. Welding the panels together on the floor of the tank does not damage the coated soil facing side of the steel.
