# COATINGS AND ANTI CORROSION ENGINEERING REVIEW

June - July 2016 | Volume 7 Issue 2 | ₹ 100

# Corrosion Protection with New Cost-Effective Coating

Compared to traditional corrosion resistant coatings, Chemically Bonded Phosphate Ceramics can stop corrosion, extend equipment life, and minimize costly production downtime

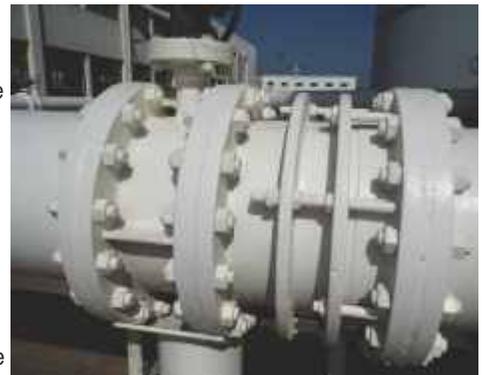
In contrast to traditional polymer coatings that sit on top of the substrate, the corrosion resistant coating bonds through a chemical

reaction with the substrate, and slight surface oxidation actually improves the reaction. An alloy layer is formed. This makes it impossible for corrosion promoters like oxygen and humidity to get behind the coating the way they can with ordinary paints. The corrosion barrier is covered by a ceramic shell that resists corrosion, fire, water, abrasion, chemicals, and temperatures up to 400 °F.

Visible in scanning electron microscope photography, EonCoat does not leave a gap between the steel and the coating because the bond is chemical rather than mechanical. Since there is no gap,

even if moisture was to get through to the steel due to a gouge, there is nowhere for the moisture to travel. The only spot that can corrode is the scribe line itself, which eliminates the possibility of the corrosion migrating.

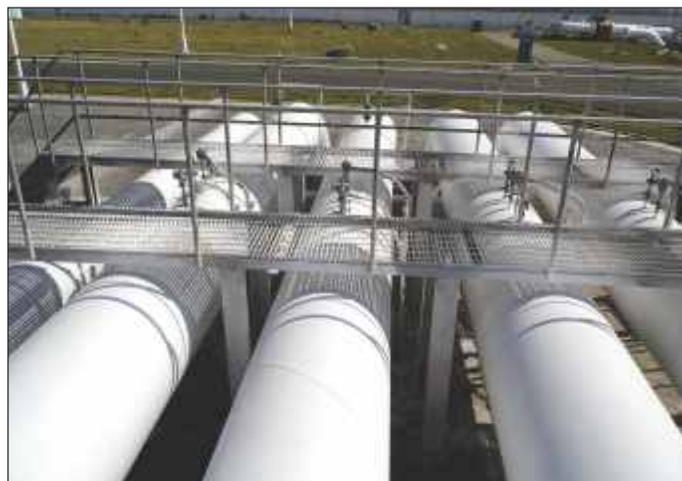
After good results, DC Metal Construction coated the inside of a clarifier tank at the Texas wastewater facility as well.

“In the five steel tanks we have sprayed with EonCoat in the past six years, we have had no corrosion issues, and no need for patching,” says Hobbs. “From the results we are getting, I believe the corrosion resistant coating can add decades of low-maintenance, usable life to carbon steel tanks and other structures.”

Since the corrosion resistant coating withstood the harsh wastewater tank immersion
