Different Approach to Managing Corrosion Under Insulation

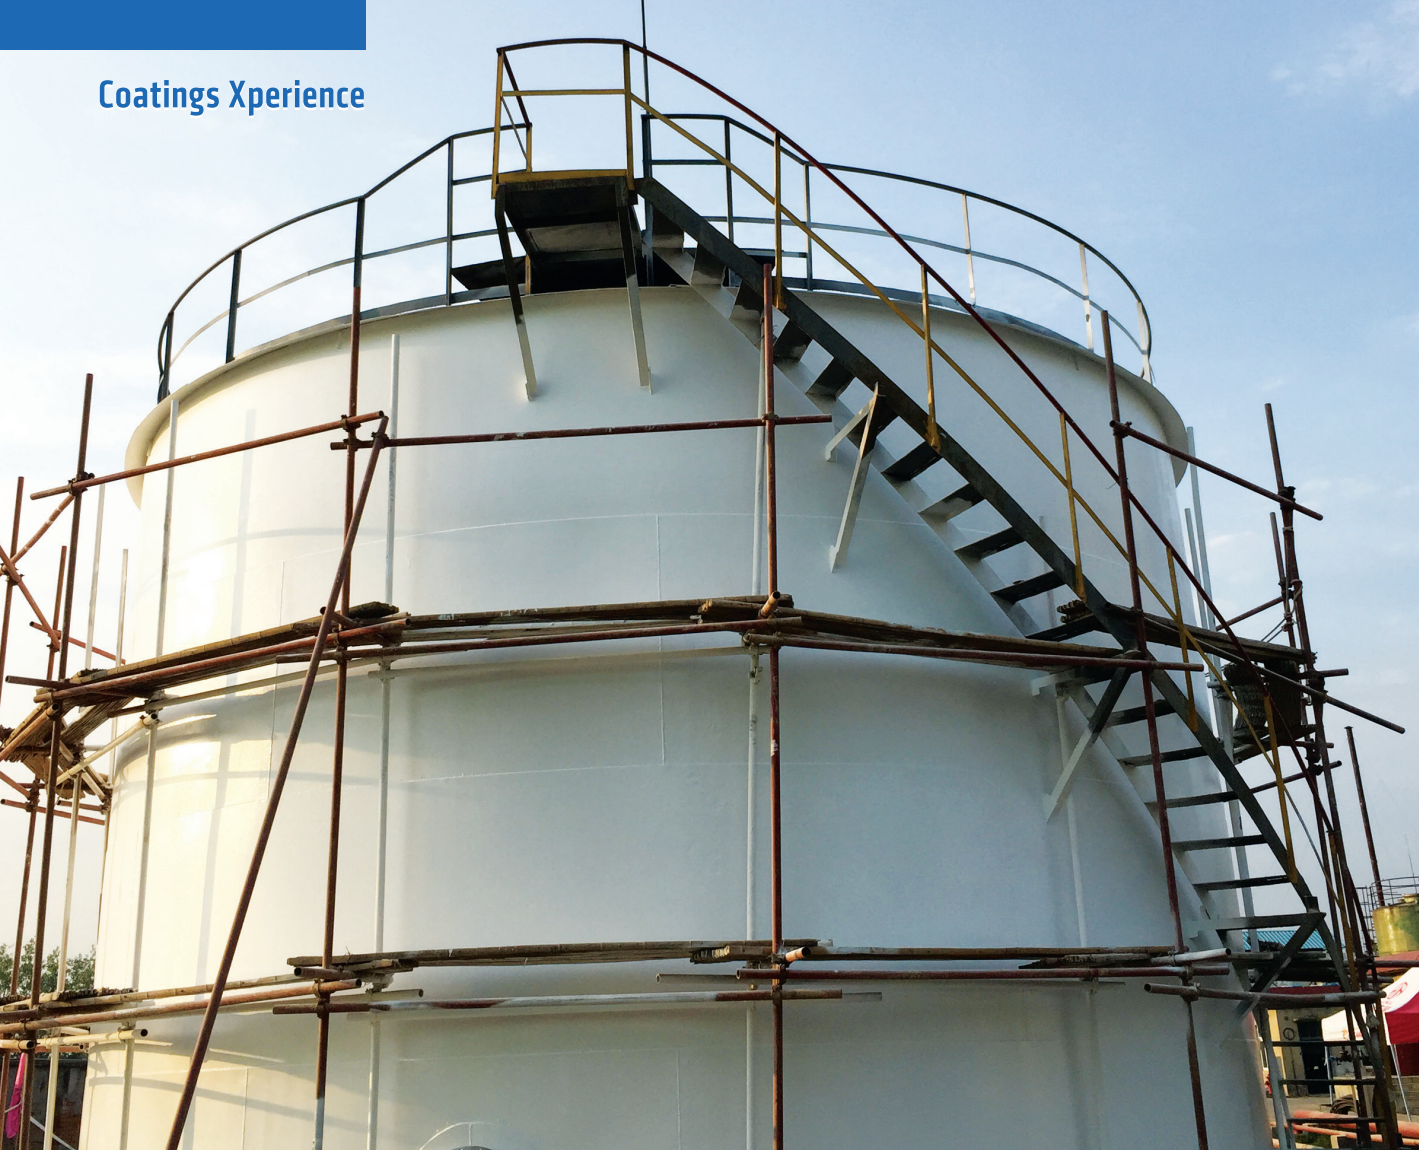
Chemicals, oxygen, and moisture cannot penetrate this layer, even if it is scratched or gouged.

Recognizing the limitations of organic, polymer-based protective coatings, EonCoat, based in Raleigh, NC, developed an inorganic alternative that addresses these shortcomings for steel processing equipment. Spray-applied EonCoat is a chemically bonded phosphate ceramic (CBPC) that bonds through a chemical reaction with the substrate. The presence of a low level of surface oxidation provides a source of iron that promotes the reaction, which results in the passivation of the steel surface due to the formation of a magnesium iron phosphate alloy layer, according to Merrick Alpert, president of EonCoat. Chemicals, oxygen, and moisture cannot penetrate this layer, even if it is scratched or gouged. The chemical transformation of the steel surface into an alloy of stable oxides prevents corrosion from spreading beyond the damaged area. The alloy barrier layer is covered with a ceramic layer that further resists corrosion, water, fire, abrasion, impact, chemicals, and temperatures up to 400°F, Merrick notes. “CBPC coatings can control corrosion for decades, reducing the need for maintenance, downtime, and the potential for incidents and therefore leading to cost savings and increased efficiency and safety of processing operations,” he asserts.

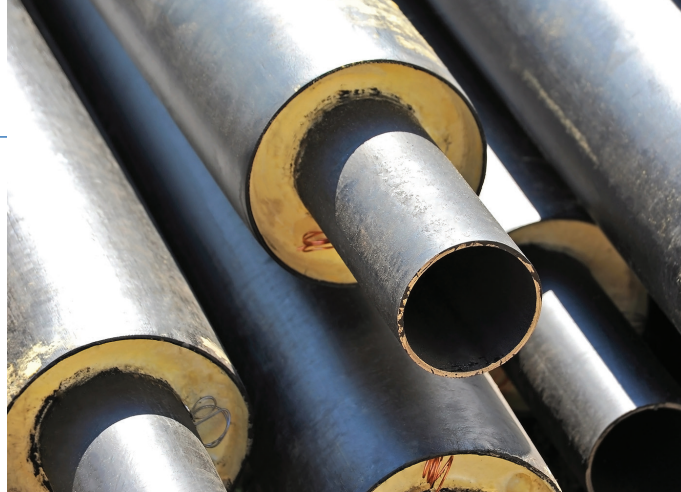
Once the coating is breached, it—and the insulation on top of it—can trap the water and any chemicals that promote corrosion, leading to CUI.

Polymer-based epoxy, polyurethane, and siloxane-based coatings are widely used for corrosion prevention. These types of coatings, however, only provide protection as long as they remain unblemished. Scratches, chips, and even tiny pinhole defects allow sufficient ingress of water and chemicals that can lead to corrosion. Once the coating is breached, it—and the insulation on top of it—can trap the water and any chemicals that promote corrosion, leading to CUI.
